9 Facility Assessment

CENTENNIAL REC CENTER / CLUB FITNESS

1776 West Centennial Place

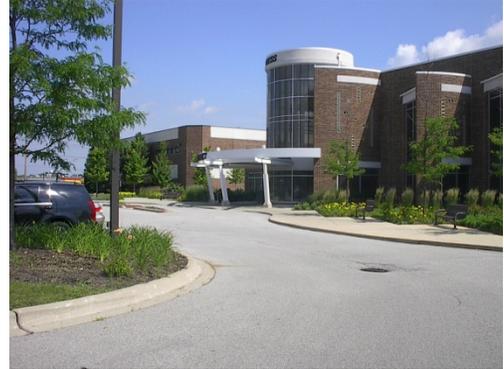
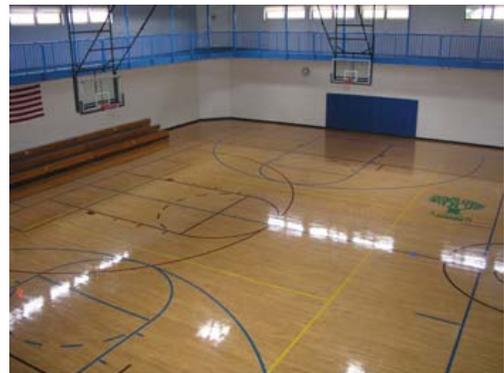
Centennial Rec Center is a west side recreation and fitness facility featuring a gymnasium with running track, multi-purpose rooms, dance room and preschool programs. Club Fitness is located adjacent to the Rec Center and comprises a state-of-the-art fitness center with cardio and free weight areas, running track, locker rooms and an indoor lap pool. In partnership with Athletico, physical therapy is offered at the facility. A large portion of the original building in which the Rec Center is located houses the Northeast DuPage Special Recreation Association (NEDSRA), which provides cooperative recreation programs for people with disabilities. The original Rec Center building was built in 1985 and the Club Fitness addition opened in 2004. Overall the buildings are in very good condition and well maintained.

Access	Good
Parking	Very Good
Accessibility	Good
Program Space	Good
Gymnasium	Good
Fitness	Excellent
Indoor Pool	Very Good
Signage	Good
Landscaping	Very Good
Maintenance	Very Good

- 1 Monitor crack in gymnasium wall, repair if movement is witnessed.
- 1 Provide regular maintenance inspections to monitor roofing and building shell for potential leaks and corrosion / repair as needed.
- 1 Improve mechanical and dehumidification system for indoor pool to eliminate corrosion, condensation and negative pressure concerns.
- 1 Remove crumbling fireproofing from within gymnasium space.

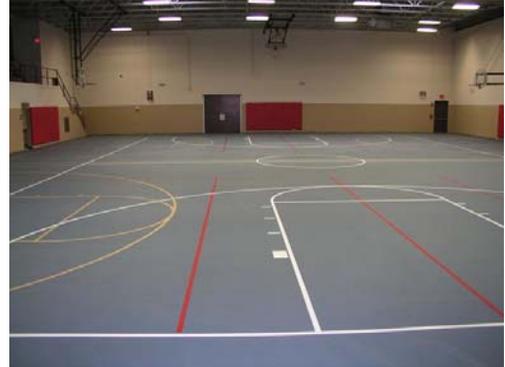
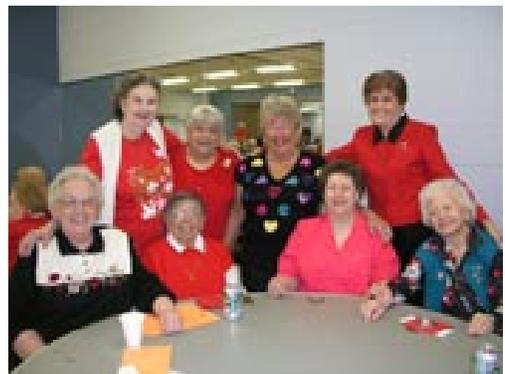
The facility has an east side location within the community and is located in area which will be adjacent to the future “downtown” according to the Village of Addison Town Center Redevelopment Master Plan. While the physical location and current facility amenities are great strengths of this facility, many existing conditions could be improved to attract new and more users to the Rec Center.

A 2008 Master Plan has been developed for the Community Rec Center outlining many facility deficiencies and needs. The goal of the recommendations is to improve life safety and ADA accessibility throughout the building, optimize administrative staff functionality, facilitate pedestrian and vehicular access to the building and provide new and expanded program space for preschool, gymnastics and other new programs. Implementing these proposed building improvements will ensure continued viability for an east side recreation facility for many years.

Access	Good
Parking	Very Good
Accessibility	Poor
Program Space	Good
Gymnasium	Good
Signage	Good
Landscaping	Very Good
Maintenance	Very Good

- 1 Improve interior building security
- 1 Improve the exterior area of the main entrance
- 1 Implement facility maintenance, life safety and ADA recommendations
- 1 Provide new program space
- 1 Upgrade the gymnasium
- 1 Consolidate Administration

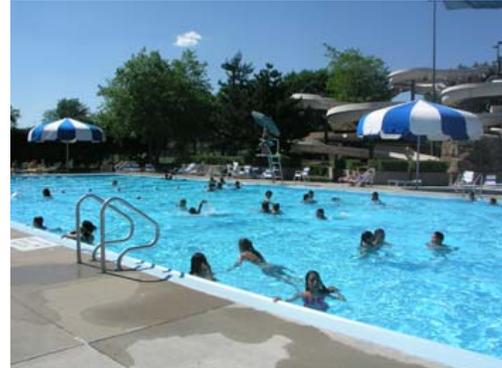
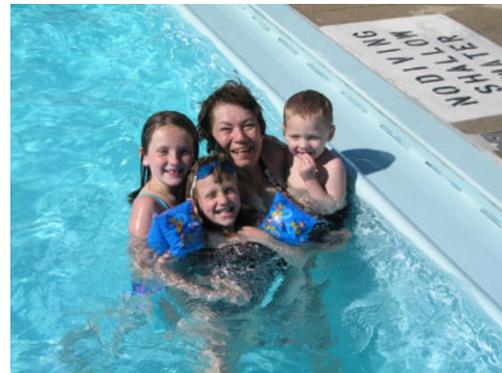
The Family Aquatic Center currently consists of one main pool and a splash pad, and offers amenities such as concessions, shade and pool deck seating. The main body of water is a 6 lane 50 meter L-shaped pool constructed in 1975. The "L" portion of the main pool is a 6 lane, 25 yard pool also constructed as a diving well for 1 meter and 3 meter diving boards. A splash pad was added to the facility in 2007, replacing an unusable kiddie pool. The splash pad is designed with the flexibility to be operated as part of the main pool or independent from the pool, which allows operation before or after the official pool season if desired. While the splash pad is great for children age 6 and younger, it does not contain standing water and does not serve as a kiddie pool.

A main drawback of the Family Aquatic Center is a lack of programmable and recreational water with a depth between 2 feet and 3 feet 6 inches, which is used most often by toddlers and children. A recent pool Audit indicates the Community Pool has a number of deficiencies that require major repairs or complete replacements, and suggests replacing the facility. The condition of the pool deck throughout most of the facility is poor, and the bath house is not considered accessible due to layout and width of internal circulation, and partially due to structural issues. The finishes in the bath house are serviceable but appear worn and unsanitary to the casual observer. The location of the facility is also a drawback, being outside public view and mindset where it attracts neither residents nor visitors to the community.

Access	Poor
Parking	Very Good
Accessibility	Poor
Main Pool	Fair
Splash Pad	Excellent
Bath House	Fair
Signage	Good
Landscaping	Very Good
Maintenance	Very Good

- 1 Modernize/rebuild the Aquatic Facility to provide more shallow water, zero depth /accessible entries and other current water play activities to appeal to a broader age group.

- 1 Build a new facility in location that is more visible and appealing to the residents of the District.

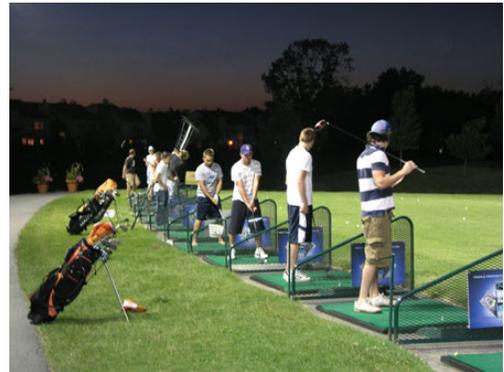
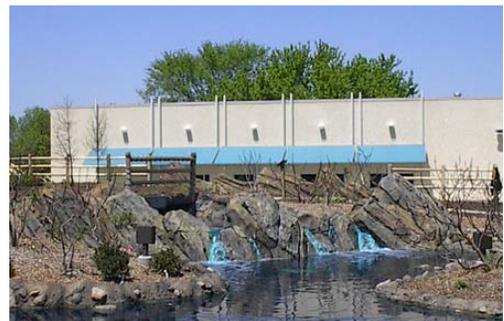
The Golf Dome is an inflated fabric structure operated during the winter season as a golf practice facility. It has a double decked range platform, service counter, manager's office and toilet rooms, all in good condition. The fabric has recently been replaced after damage by high winds. The entry building could use general upgrades to windows, doors and mechanical systems.

The Golf Course Clubhouse is a one story building with basement serving the 9-Hole Executive Par 3 course. The building exterior is in generally good condition while the interior is in fair condition. The building layout is not functional and is not ADA compliant. Consideration should be given to remodeling the building interior and bringing the facility into compliance with current building codes.

The Golf Course Maintenance Building is in generally good condition for this type of facility, but particular care should be given to maintaining the building's water tightness and insulating value.

Access	Good
Parking	Fair
Accessibility	Good
Golf Dome	Good
Mini Golf Bldg	Very Good
Clubhouse	Fair
Maintenance Bldg	Good
Ball Wash Shed	Fair
Signage	Excellent
Landscaping	Good
Maintenance	Very Good

- 1 Replace leaking windows in the Golf Dome entry building, replace air interlock maintenance door, and consider adding air conditioning.
- 1 Remodel Gold Course Clubhouse to comply with ADA requirements, add food service and outdoor shade. Provide accessible path from parking to the building.
- 1 Paint and landscape around ball wash shed.

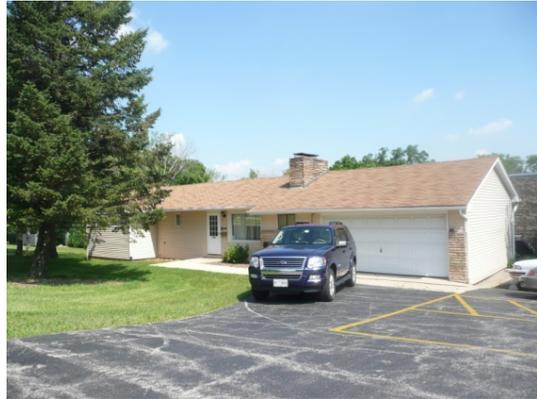
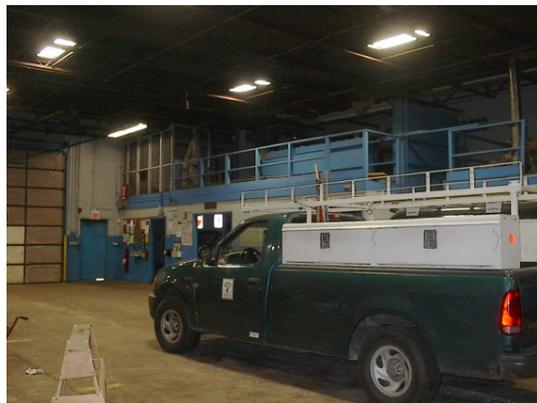
The residential building (circa 1960) is being utilized without any major modifications to the original structure. The first floor contains an open office area, private office and drafting /storage room. The lower level, which opens out at grade, contains staff changing facilities, men's toilet, cooking area and a break room. There are inactive fireplaces with hearths on both floors. The "office" building is connected to the maintenance buildings with a crude wooden "breezeway" structure which is in need of replacement.

In general the residential building used for offices is in poor condition, not in compliance with accessibility requirements, and has suspected structural, life safety and asbestos issues. The maintenance buildings are generally in fair condition for this type of use, and could be improved to good condition with ongoing maintenance.

Pavement around all the buildings is in very poor condition. Both asphalt drive way and concrete walks and curbs need to be re-built. Yard storage areas adjacent to the maintenance buildings are disorganized by their very nature and screened only by landscaping on the adjacent property.

Access	Good
Parking	Fair
Accessibility	Poor
Office Building	Poor
Maintenance Bldg	Fair
Signage	Fair
Landscaping	Poor
Maintenance	Fair

- 1 Replace wooden "breezeway" structure
- 1 Evaluate maintenance building roof and schedule to repair as necessary
- 1 Identify areas to add landscape screening of yard storage facility
- 3 Remodel or replace the residential (office) building
- 3 Schedule replacement of pavement
