8 Park Assessment

PARK EVALUATION CRITERIA

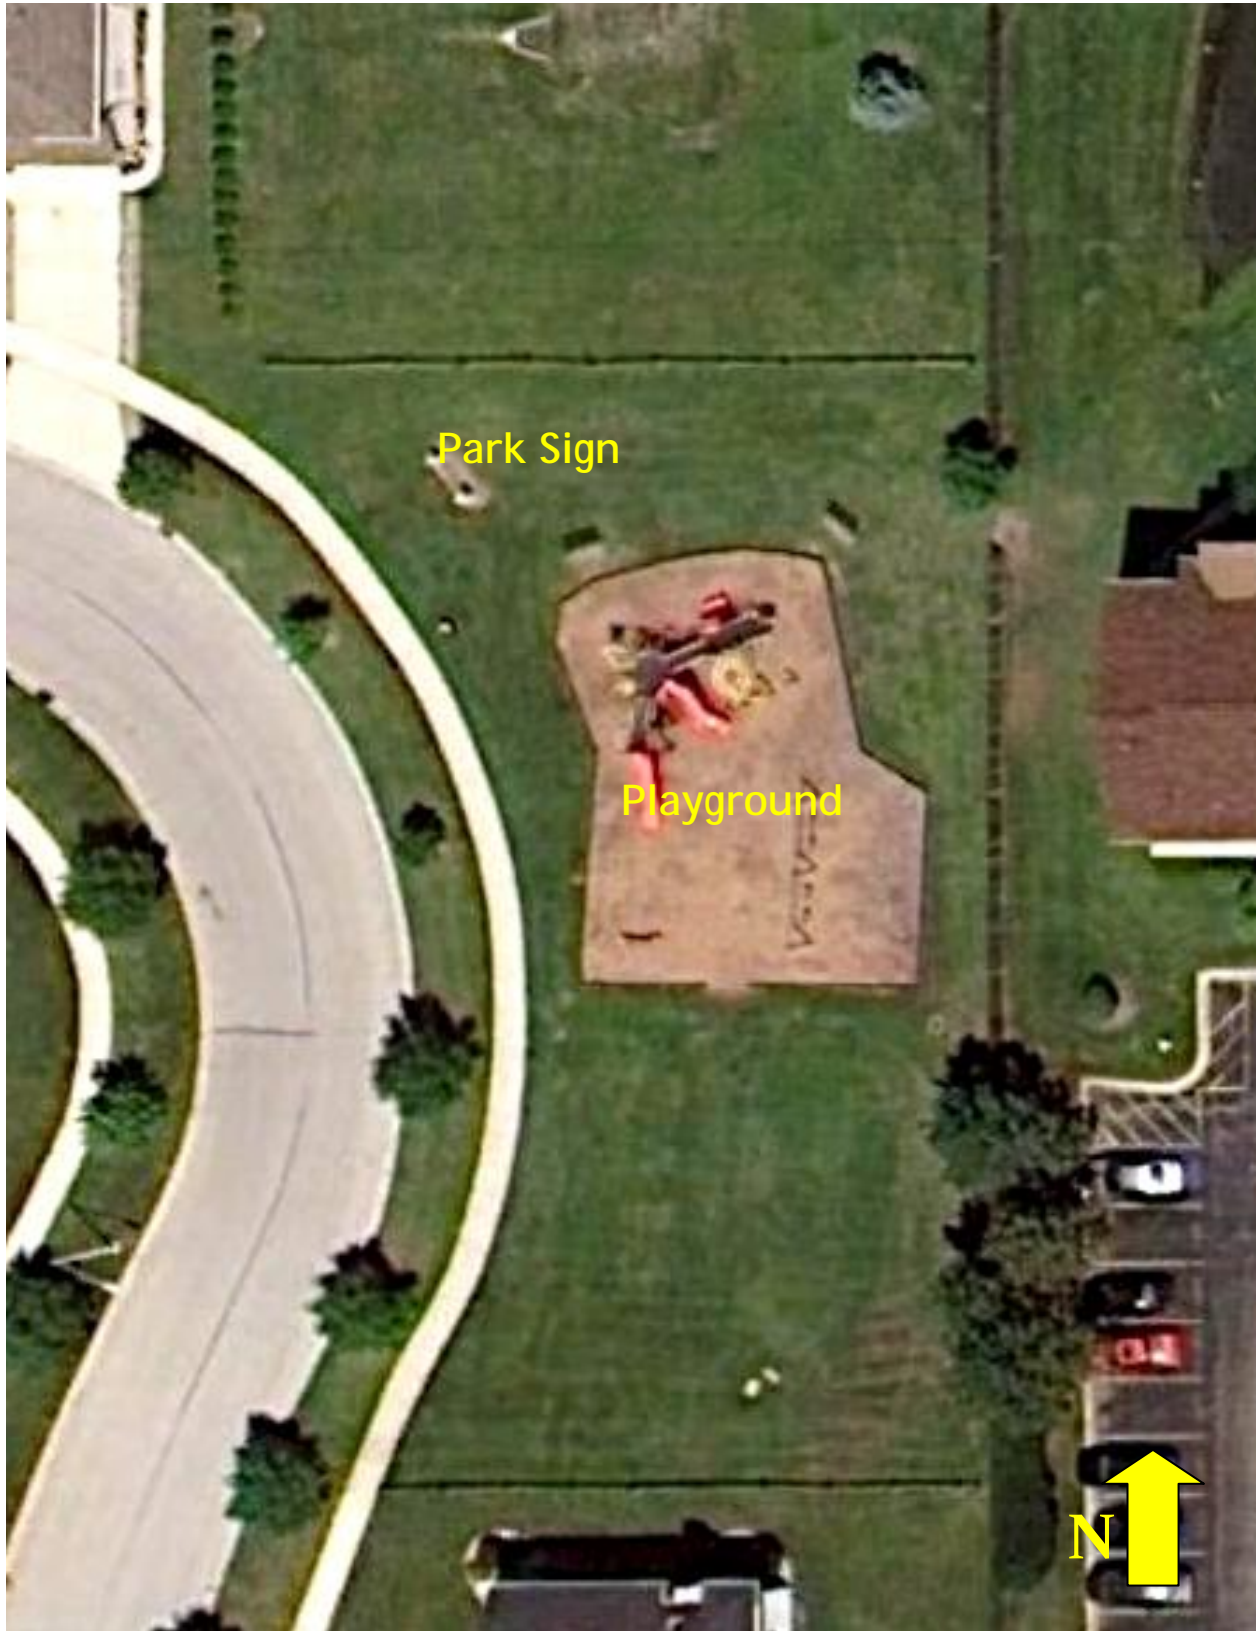
ARMANI PARK

Armani Park is a nice mini-park in a north central location with single-family homes to the west and south, multi-family housing bordering the east side and lake Street commercial just to the north. The park has a relatively new playground, constructed in 2003, that includes a good variety of play features plus swings and a spring toy. The playground has plastic edging containing an engineered wood fiber surface that does spill over into adjacent lawn areas, especially at the access point into the playground area. There is access to the park from a sidewalk along Veterans Parkway and a gate to the adjacent condominium development, but there is no walkway on-site accessing the playground. The only site furnishings are two metal mesh benches. A single barrels acts as a trash receptacle. The signage, while relatively new, is the old-style design used through most of the District. On-street parking is available. An adjacent stormwater basin adds to the ambience of the park, but is not a part of the park property. There is no landscaping within the park, and the majority of the lawn areas are clover.

Curb Appeal	Excellent
Access	Good
Playground	Excellent
Site Furnishings	Very Good
Signage	Very Good
Landscaping	Poor
Lawns	Poor
Fencing	Excellent
Maintenance	Good

- 1 Add shade trees at the playground area and as shade for the benches
- 2 Add paved apron in front of benches
- 2 Provide low landscaping to highlight the park sign
- 3 Provide an accessible paved path from the public sidewalk, and from the condominium development, to the playground.
- 3 Add a bicycle rack

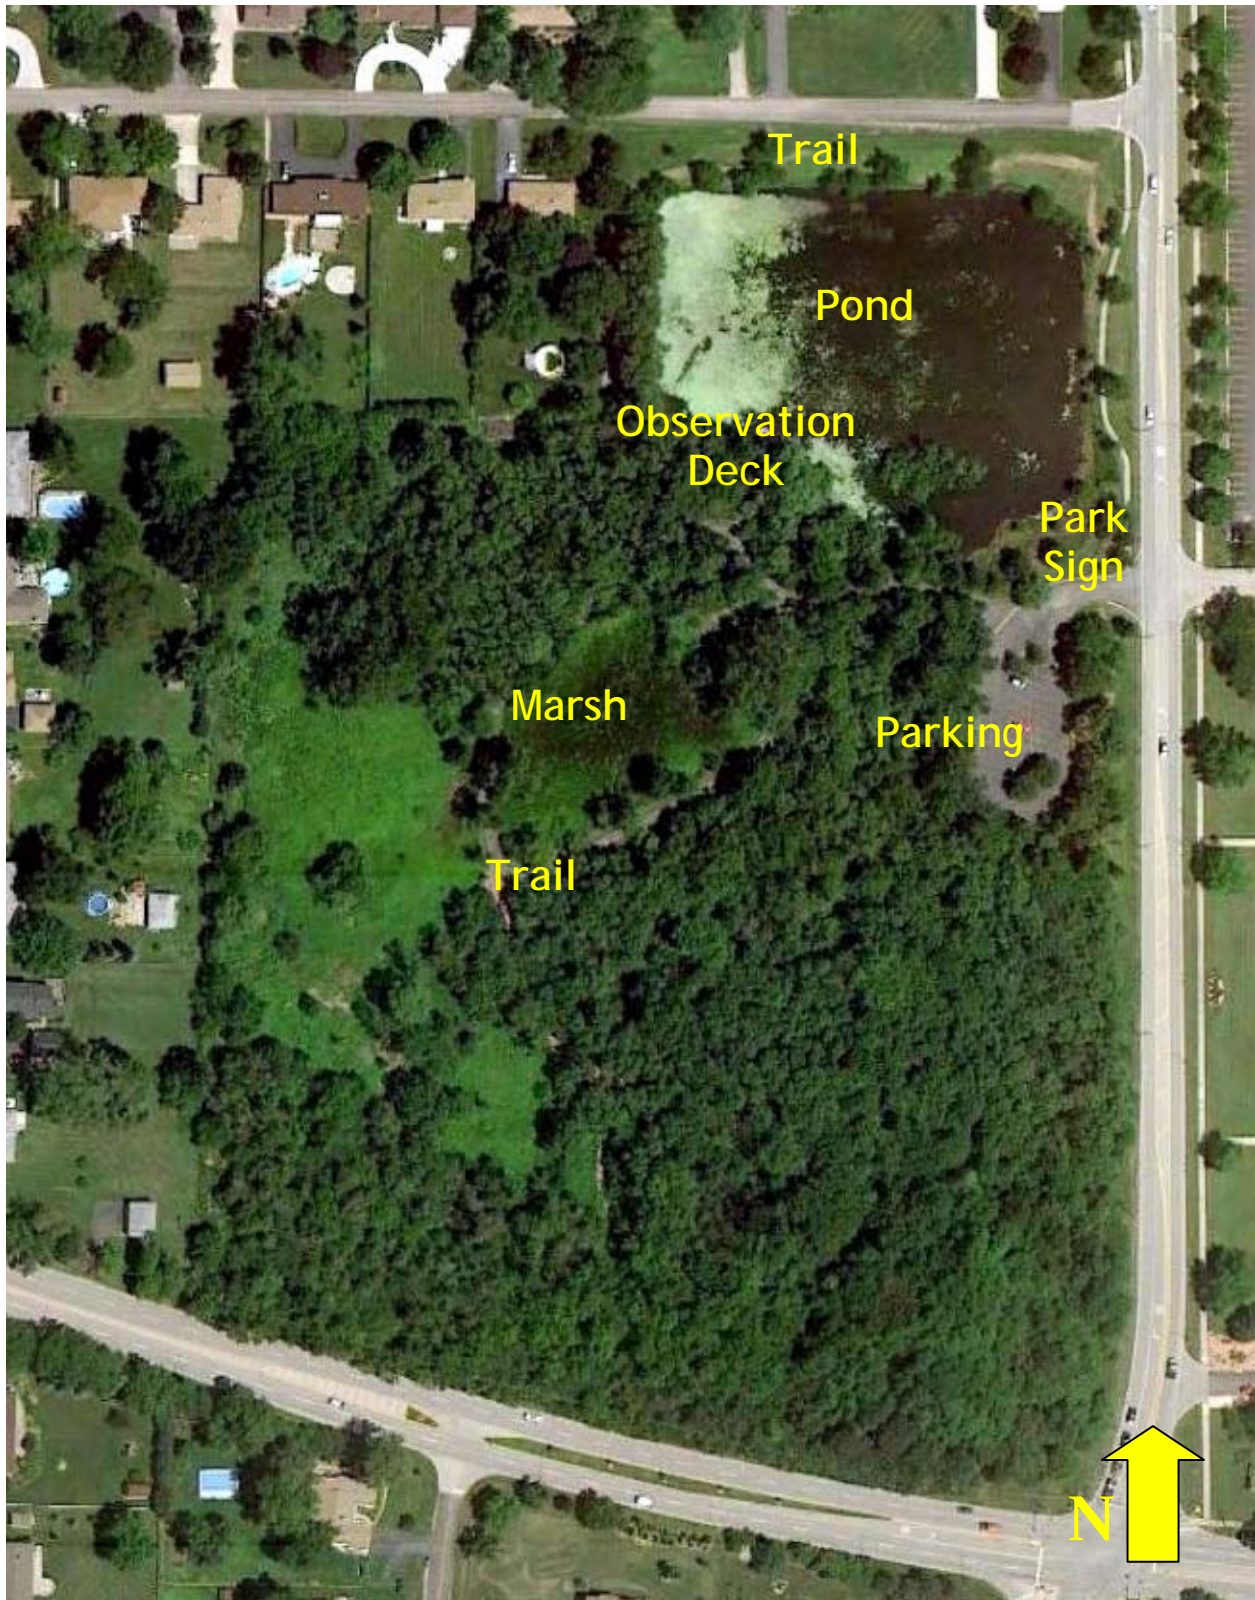
ARMY TRAIL NATURE CENTER

Army Trail Nature Center is an open lands park located on the northwest corner of Army Trail Road and North Lombard Road. The park is bordered by single-family homes on the north and west, as well as across Army Trail Road to the south. Addison Trail High School is east of the park. The park provides natural open space, with a series of paved and wood chip trails, a fishing pond, outdoor classroom area and a newly rebuilt observation deck. As a destination-type park, there is little pedestrian access from the adjacent residential areas, with car and bus parking available. The natural areas of the park consist of the pond, marshland, prairie and forest habitats. There is a kiosk for announcements and park information.

Curb Appeal	Fair
Access	Fair
Parking	Good
Trails	Fair
Site Furnishings	Poor
Kiosk	Poor
Observation Deck	Very Good
Outdoor Classroom	Good
Signage	Fair
Natural Areas	Fair
Maintenance	Poor

- 1 Rebuild/expand mulch trail system
- 1 Seal-coat parking and trails
- 1 Add native grasses and perennials to parking lot island and signage areas
- 2 Re-build second observation deck at marsh area
- 2 Replace bicycle rack
- 3 Add trail wayfinding signage
- 3 Provide a paved path from the corner of Army Trail and Lombard into the park near the sign, and work with the Village and schools to install crosswalks and sidewalk at the intersection.
- 3 Add low-level safety lighting in parking area
- 2 Build new nature center on property
- 2 Add an ADA-accessible picnic shelter to the park
- 2 Resurface parking and trails
- 2 Redesign the outdoor classroom area
- 2 Add a series of interpretive signs throughout the park for each of the various habitat areas

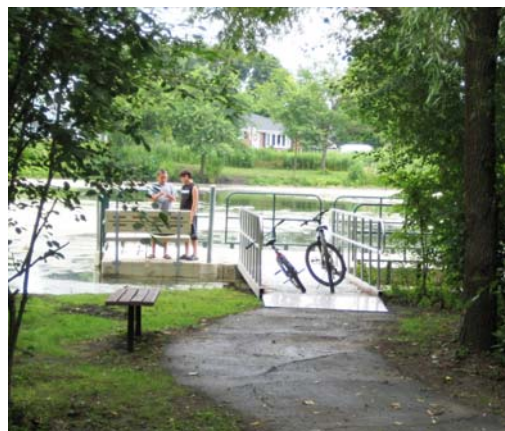
BYRON PARK

Curb Appeal	Excellent
Access	Excellent
Parking	Good
Playground	Fair
Site Furnishings	Very Good
Signage	Very Good
Landscaping	Very Good
Lawns	Poor
Tennis	Fair
Ball Field	Fair
Basketball	Good
Trails	Good
Shelter	Fair
Maintenance	Good

Byron Park is a much-used neighborhood park bordering on I-290, with residential neighborhoods to the south and west. Sidewalks provide good access from the surrounding neighborhoods, with parking available for park users as well. There is a nice berm of trees separating the park from the street, creating a very appealing park setting. Byron has a good variety of active recreation amenities, including tennis, basketball and a ball field that is used for organized games. The playground, constructed in 1998, offers a great variety of activities and is one of the larger playgrounds in the APD neighborhood park system, but is older in style and safety compliance, and due for replacement. There is a good variety of tree species in the park, with many shade trees, conifers and ornamentals. The bituminous trail around the perimeter of the park is one of the main draws of local residents.

- 1 Replace playground
- 1 Seal-coat parking and trails
- 1 Add paved apron in front of benches
- 1 Repair gazebo shelter and provide paved accessible surface
- 1 Rebuild one tennis court and change other into volleyball.
- 1 Rebuild ball field, including infield, fencing, backstop and lawn
- 1 Add paved path and paved base to ball field bleachers
- 1 Replace bicycle rack
- 1 Redesign/replace wayfinding signage
- 1 Provide soccer goals that can be used for pickup games
- 2 Work with Village to provide additional crosswalks at appropriate locations

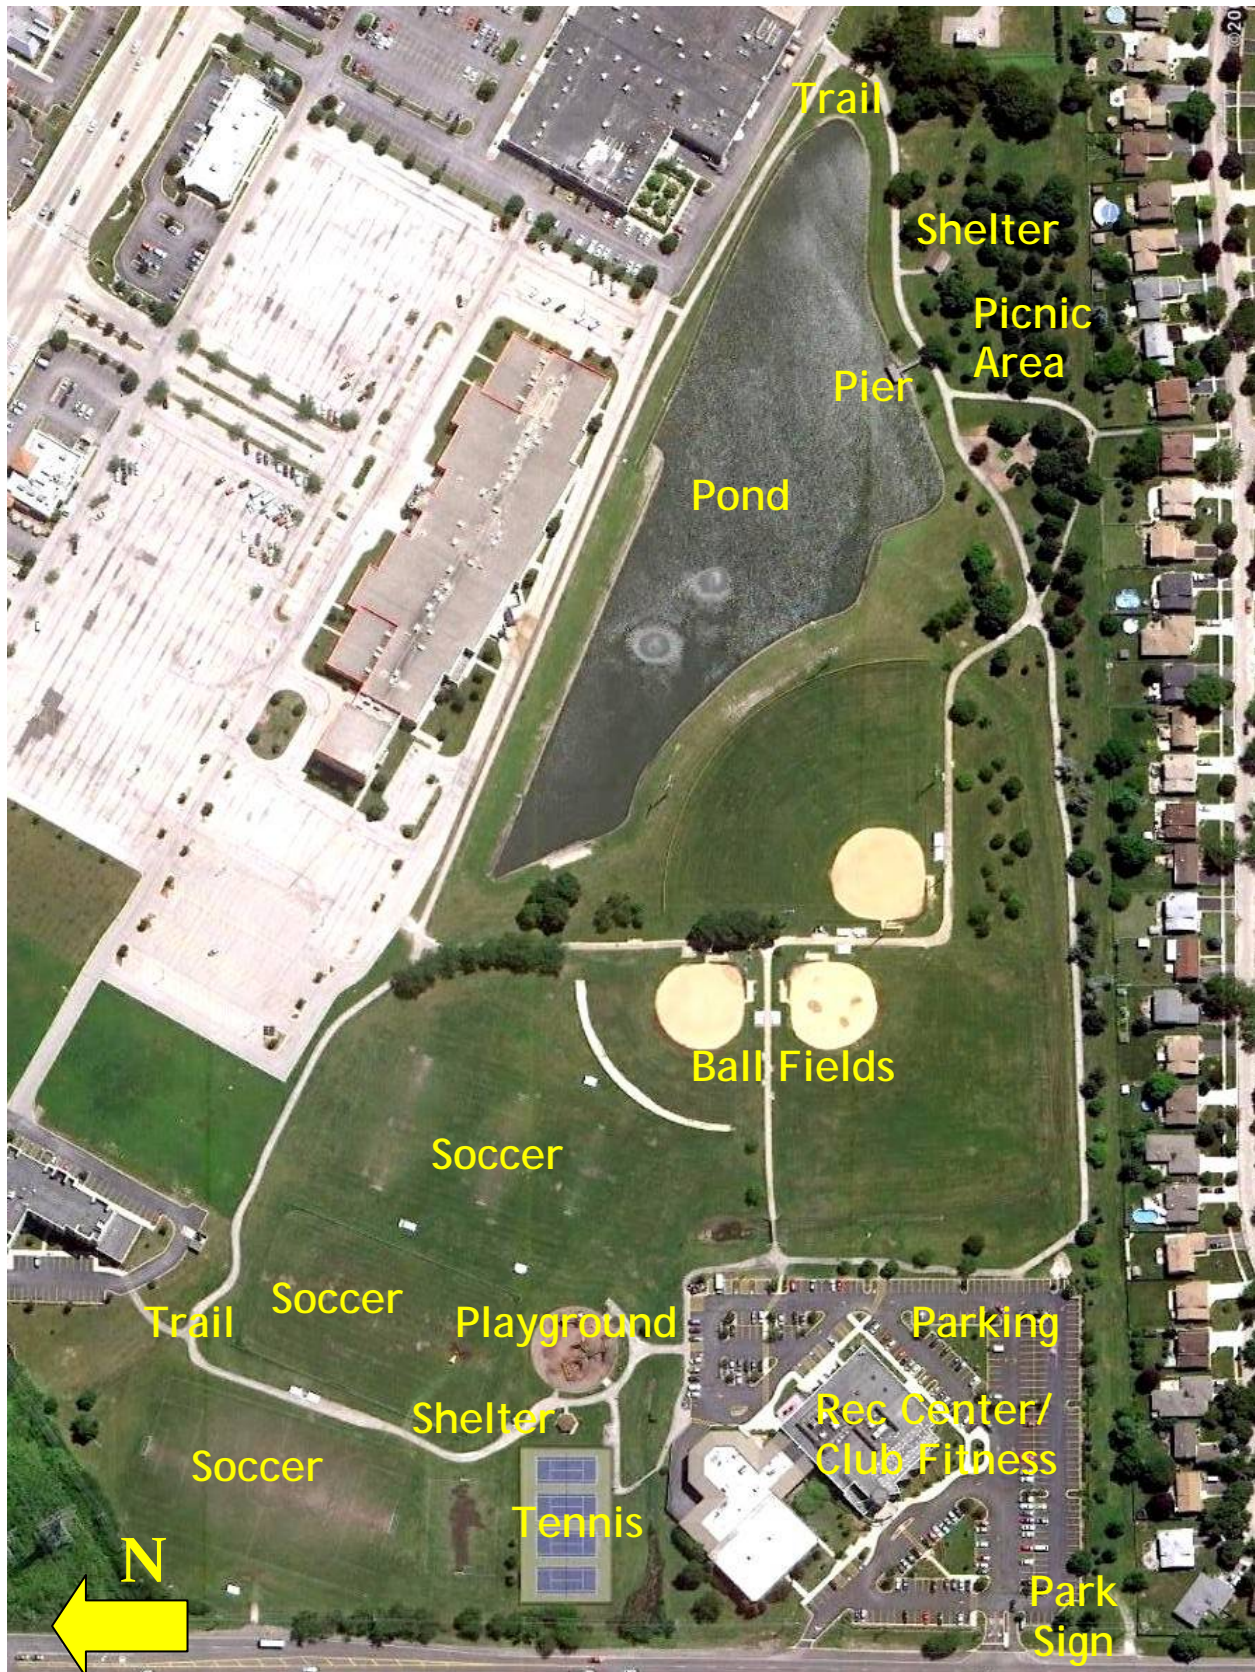
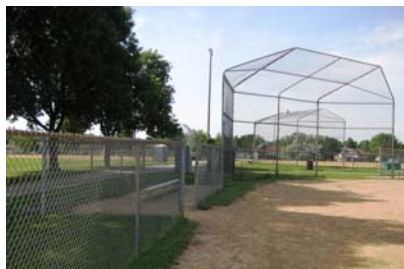
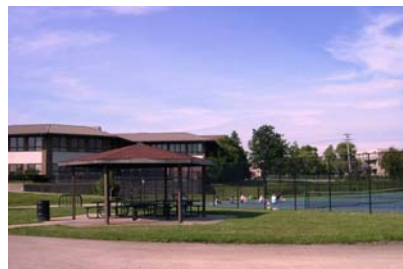
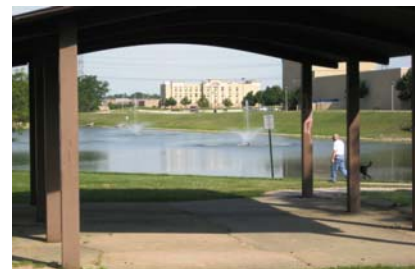
CENTENNIAL PARK

Home to Centennial Rec Center and Club Fitness, Centennial Park is a large community park that offers a wide array of amenities that are used by the surrounding neighborhood residents as well as the community as a whole. Located just off Rohlwing Road, the park is adjacent to Centennial Plaza Shopping Center to the north, residential to the south and a variety of commercial/business properties to the west. As a destination park, there is substantial parking to accommodate simultaneous uses. Pedestrian access is limited, with no sidewalks on Rohlwing, three access points from the shopping center and only one from the residential neighborhood. The park amenities include ball fields and soccer fields used for organized sports, a set of resurfaced tennis courts, a diverse playground, picnic area, memorial area, pond and overlook. The trail system is extensive and much-utilized. Landscaping at the buildings is well-done, and there is a good variety of trees through-out the park; though additional trees for shade at the playground and other areas will be beneficial.

Curb Appeal	Fair
Access	Good
Parking	Very Good
Playground	Very Good
Site Furnishings	Very Good
Signage	Good
Landscaping	Very Good
Lawns	Good
Tennis	Very Good
Ball Field	Very Good
Soccer	Very Good
Trails	Very Good
Shelters	Good
Maintenance	Very Good

- 1 Rebuild concrete pad at east shelter
- 1 Replace older benches to match newer style selected for park branding
- 1 Resurface walkways and add paved aprons in front of benches
- 1 Replace drainage structure at trail access from residential neighborhood
- 2 Rebuild ball fields, including infield resurfacing, new fencing and backstops, dugout and bleacher pads, and lawns
- 2 Replace drinking fountains and add fountains near active use areas
- 2 Add shade trees at the playground area, tennis, ball fields, etc.
- 3 Redesign and move memorial area
- 3 Re-surface east tennis court to remove raised area
- 4 Consider adding fitness stations and a larger fitness pod at memorial location
- 4 Develop artificial turf soccer field
- 4 Develop pool/aquatics complex per master plan

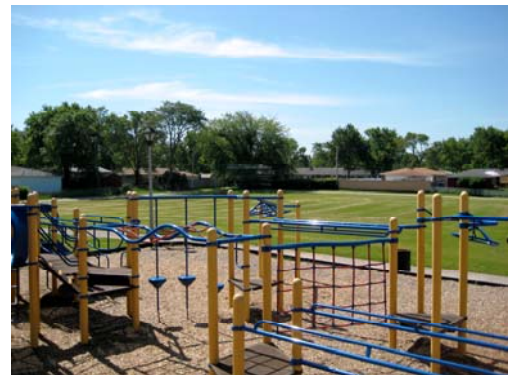
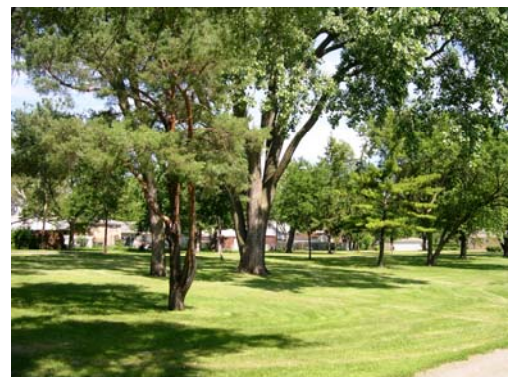
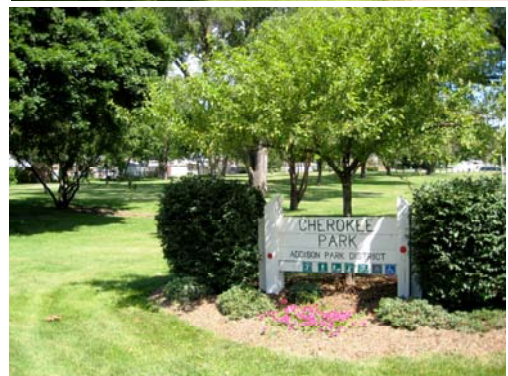
COMMUNITY PARK

Community Park is a large community park that is home to the Community Rec Center, Senior Leisure Center and Family Aquatic Center. The park borders on a variety of land uses, with single and multi-family housing, business offices and commercial properties adjacent. East of the park is the Salt Creek corridor and I-290. Sidewalks into the park provide good pedestrian access. Because Community is a destination park, there is substantial parking available off Oak Street. There are five ball fields here, all used for organized games, including the field that is home to the Addison Braves semi-pro baseball team. Though not designated as such, there is an open lawn area just west of the pool that is used by the neighborhood for informal soccer games. There is a large, divided playground area serving children of various ages, but its location does not provide easy neighborhood access. There is a large picnic area in the park, as well as a nice patio area off the senior wing of the Rec Center building. In general, the landscaping is at the Rec Center and a good variety of trees throughout the park; though the lawn areas have significant weed and clover growth. Because of the heavy use that this park sustains, redevelopment of existing athletic fields and addition of new and varied amenities is a top priority for the community and the neighborhood.

Curb Appeal	Fair
Access	Good
Parking	Good
Playground	Poor
Site Furnishings	Good
Signage	Good
Landscaping	Good
Lawns	Fair
Ball Fields	Fair
Sled Hill	Good
Trails	Good
Maintenance	Very Good

- 1 Replace playground in a different location
- 1 Replace older picnic tables
- 1 Add bicycle racks at ball fields, picnic area and Rec Center
- 1 Rebuild ball fields, including infield resurfacing, fencing, backstops, dugouts, bleacher, lighting, irrigation, drainage, storage, lawns, drinking fountains, etc.
- 1 Replace/Add drinking fountain(s)
- 1 Redesign patio space landscape for safety
- 1 Add sand volleyball court and basketball court
- 1 Provide soccer field area/goals that can be used for neighborhood pickup games
- 1 Redesign trail and connect to west neighborhood and Salt Creek Trail
- 1 Add modern fitness stations along trail system
- 1 Replace park sign and move existing sign to Salt Creek Trail entry area

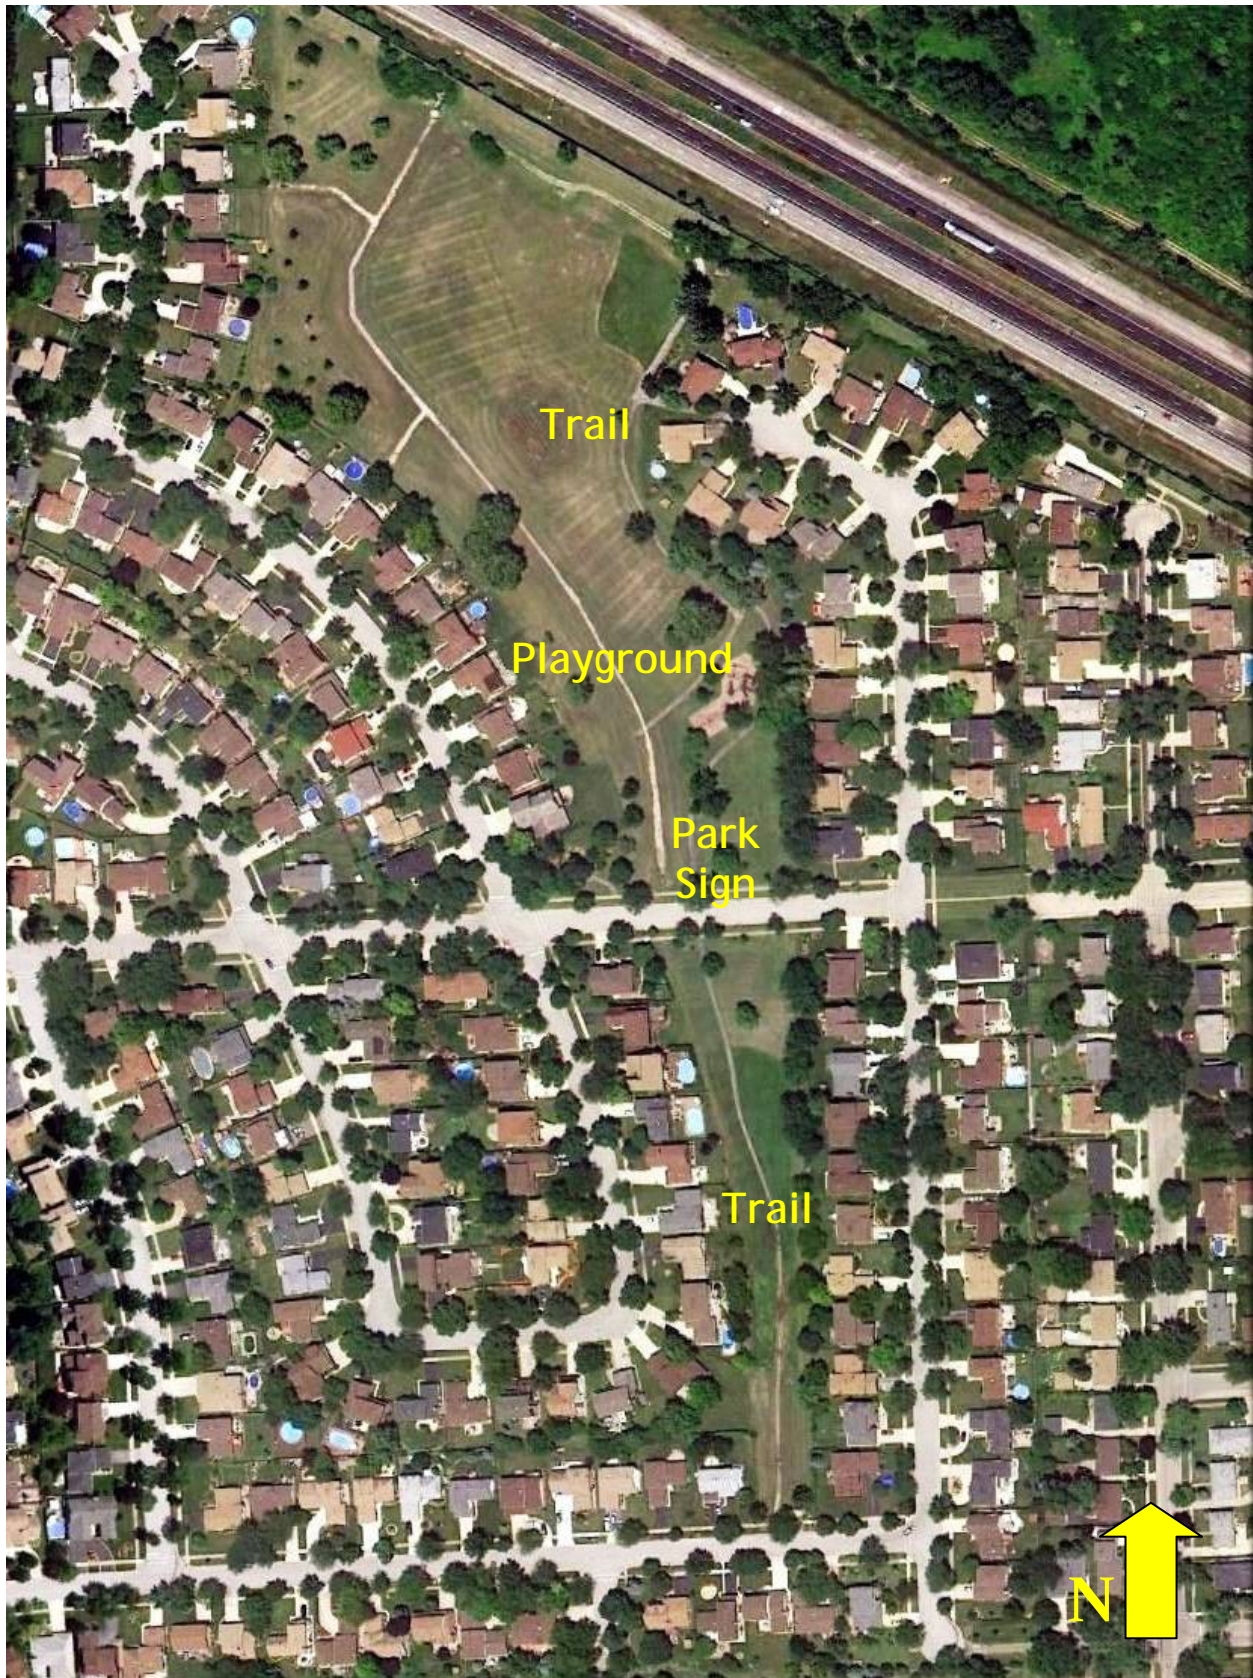
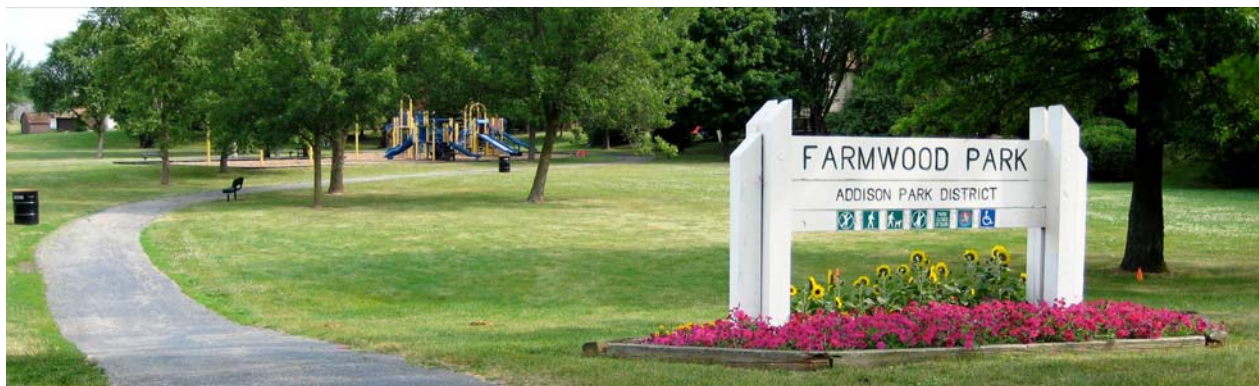
FARMWOOD PARK

Farmwood Park is a neighborhood park that also serves as general open space in a dense residential area. Bordering on I-290 to the north, Farmwood's linear shape extends down to Surrey Road on the south. Neighborhood access to the park is good, with public access paths in various locations. A possible access path off White Fence Lane has never been constructed, though the ROW exists between two houses. The access from Surrey is only fair, where the elevation change causes a need for stairs to get into the park. The elevation difference is a result of the park's primary purpose, that as a stormwater management area; meaning that the park is subject to periodic flooding. The only amenities in the park are the trail and a playground that, while providing a good variety of play features, is in need of replacement. The trail north of Sable Drive is limited as it ends at a gravel path that provides utility access to drainage structures on the site and is not designed as a pedestrian trail. A small wooded sitting area is found in the corner of the park, offering a good place to simply

Access	Good
Playground	Fair
Site Furnishings	Very Good
Signage	Very Good
Landscaping	Very Good
Lawns	Fair
Maintenance	Good

- 1 Replace the playground
- 1 Repave the trails
- 2 Add a bicycle rack
- 3 Remove large expanses of lawn area in favor of native plantings that will withstand periodic flooding
- 4 Explore options for an ADA-accessible trail from Surrey Road
- 4 Provide a paved path around the circumference of the park
- 4 Consider adding the White Fence Lane access trail to the park

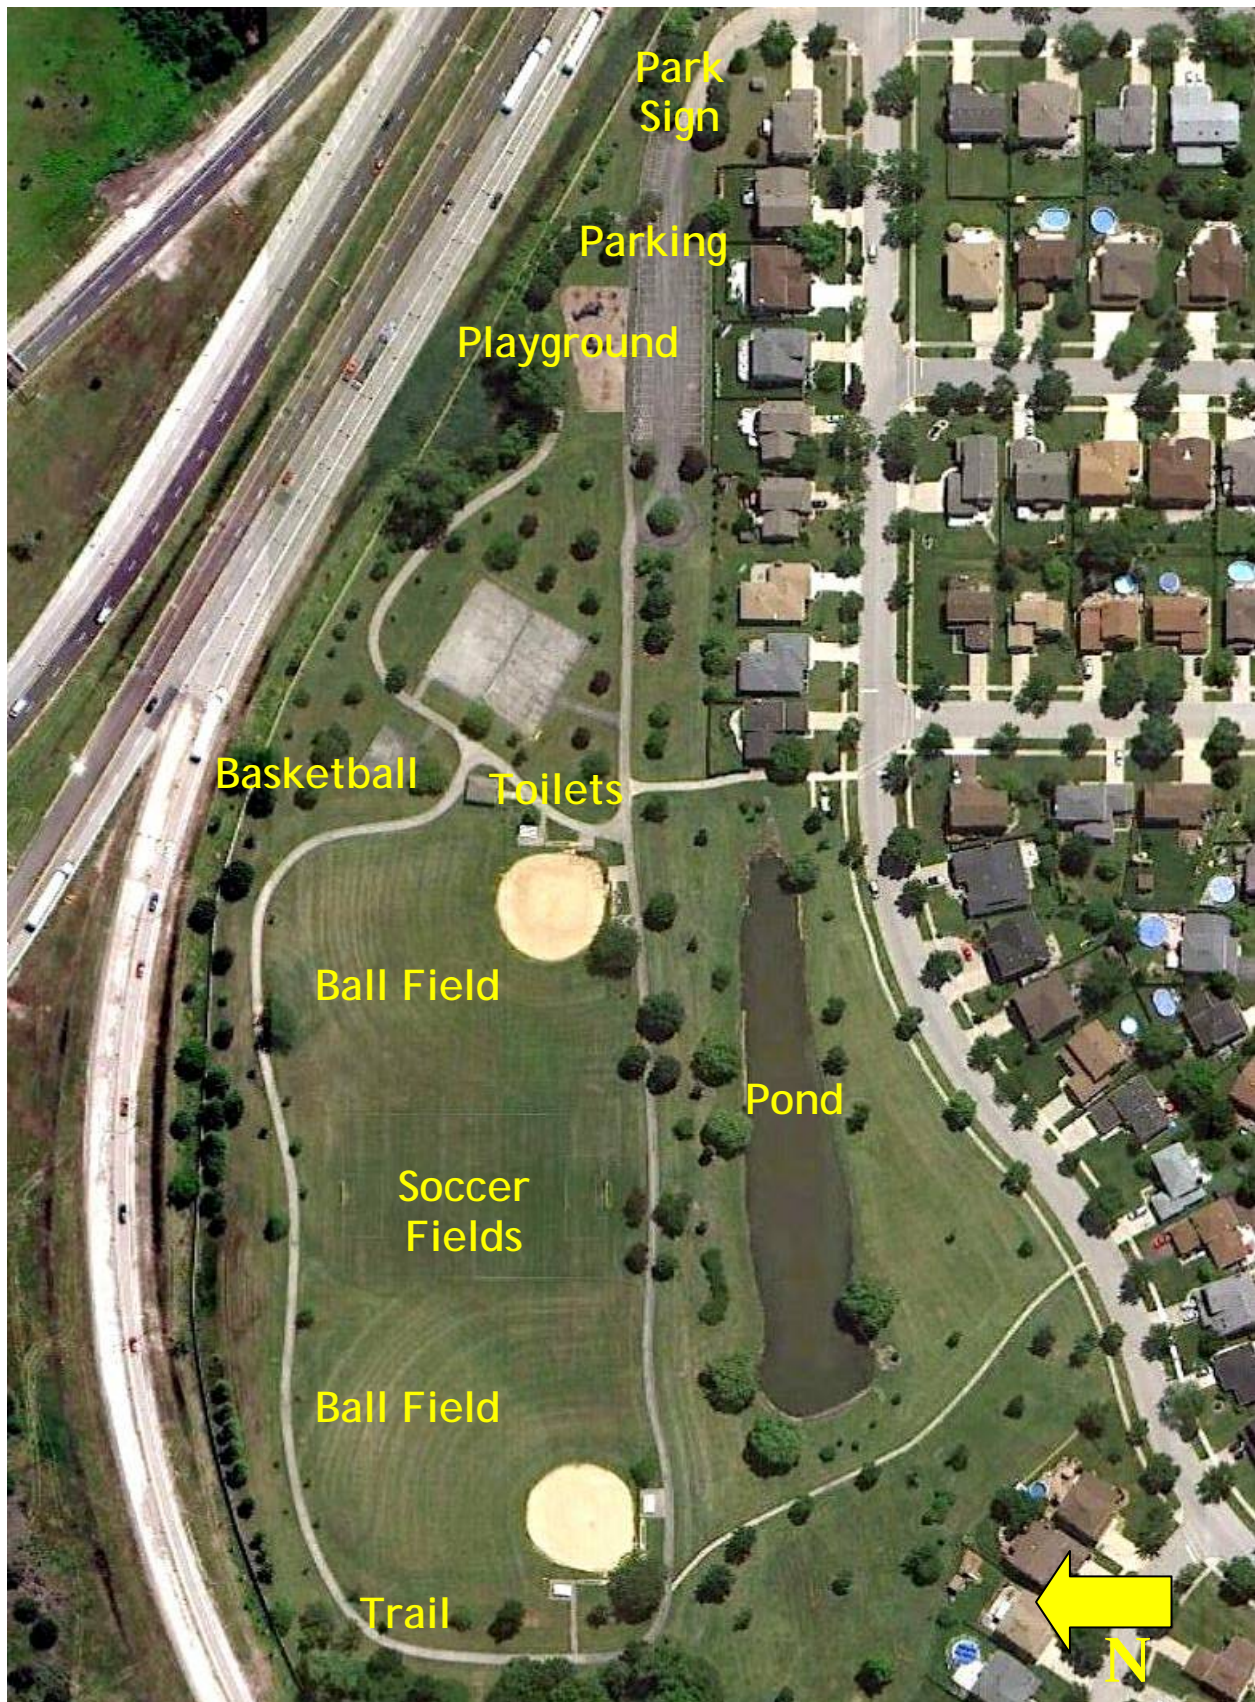
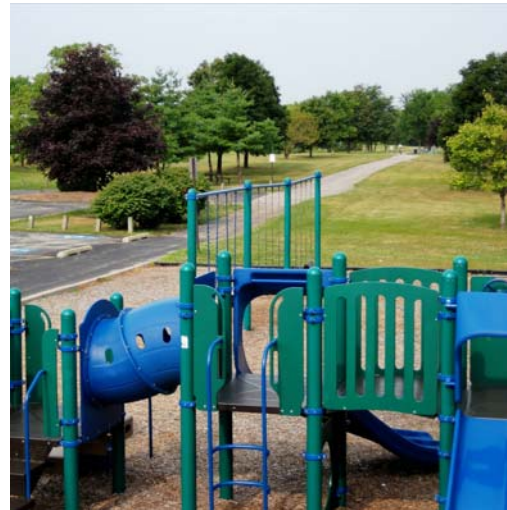
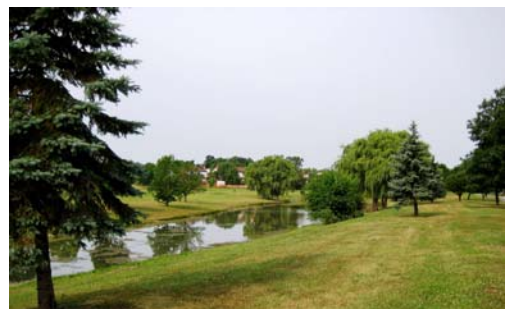
FOXDALE PARK

Foxdale Park is a large neighborhood park that borders a residential neighborhood to the south and the ramp connecting I-355 and I-290 to the north. The park has a great street presence, though the access into the parking lot is not very inviting. The parking area is adequate, but may be undersized for the current and potential uses of the park. Neighborhood access is provided by two trails into the park from the south. There are two ball fields and four soccer fields that cater to organized league games, while the other amenities are for neighborhood use. The playground is relatively new and provides good variety. The basketball surface is in need of repair. The pond area provides a nice natural feature in the area that could be enhanced through native plantings. There is a significant amount of clover throughout the park, including on the sports fields. A nice variety of trees are planted throughout the park, though the playground is in constant sun.

Curb Appeal	Excellent
Access	Excellent
Parking	Fair
Playground	Very Good
Site Furnishings	Very Good
Signage	Fair
Landscaping	Very Good
Open Space	Excellent
Lawns	Good
Skate Court	Poor
Ball Fields	Fair
Basketball	Fair
Trails	Good
Maintenance	Good

- 1 Replace ball field backstops and fences, raising the height of fencing for safety purposes
- 1 Resurface basketball court and paint backboard/post
- 2 Add a bicycle rack
- 2 Move existing playground to former tennis court area and expand parking at existing playground area
- 3 Add shade trees at the playground area
- 3 Resurface entry drive, parking and bituminous trails
- 4 Remove large expanses of lawn area in favor of native plantings near the pond and other non-sports areas
- 4 Add disc golf course

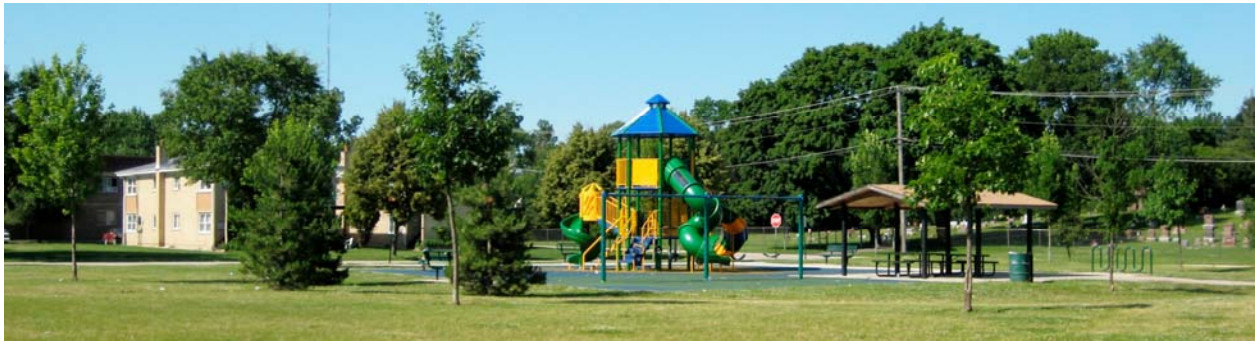
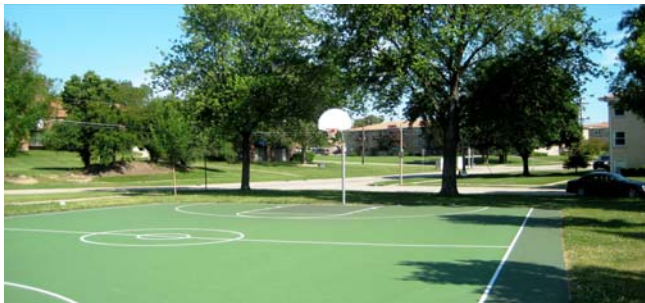
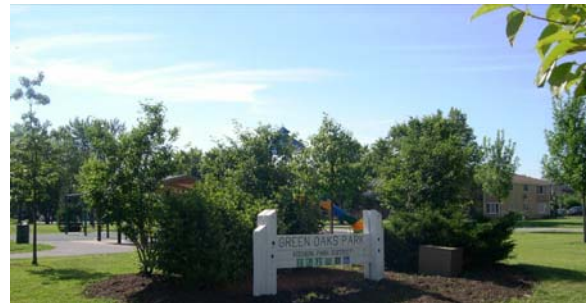
GREEN OAKS PARK

Curb Appeal	Excellent
Access	Excellent
Playground	Excellent
Shelter	Excellent
Site Furnishings	Very Good
Signage	Excellent
Landscaping	Very Good
Lawns	Poor
Ball Field	Very Good
Basketball	Excellent
Trails	Excellent
Maintenance	Good

- 1 Provide soccer goals that can be used for pickup games

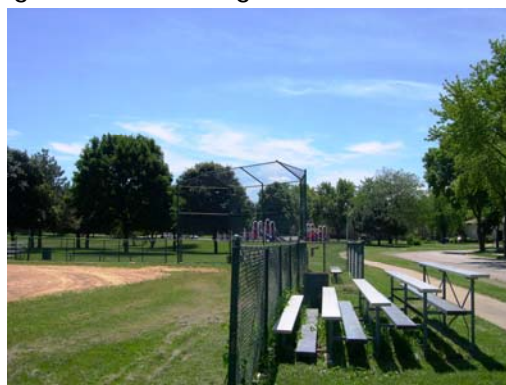
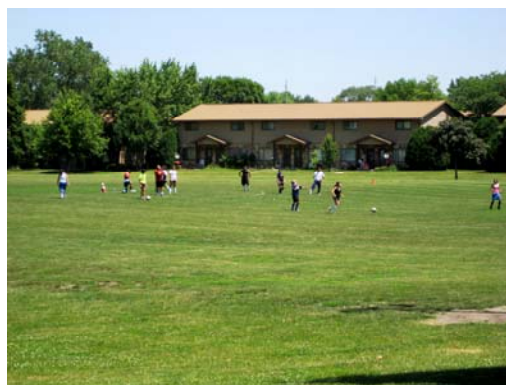
HIGHVIEW PARK

Highview Park is a large neighborhood park on the east side of the community. Single and multi-family housing surround the park, with the apartment complex on the east side bordering directly on the park. Access to the park is accommodated through sidewalks surrounding virtually the entire park. Parking is available on-street, with perpendicular parking along Diversey Avenue. The park is very inviting from outside the surrounding areas. The park is very active-recreation oriented, with a variety of athletic fields and courts and other active amenities. The playground is over-used and is subject to ongoing vandalism. The ball field is rarely used even for pick-up games, while the soccer field is used for organized games and gets significant use for pick-up games as well. Both fields have surface problems, with the soccer field over-elevated in the midfield area and right field of the ball field being very low and wet. The tennis courts are in need of upgrade and possibly removal. The site furnishing are generally old and in need of replacement. There are a significant number of large trees in the park, with those overhanging the tennis courts causing a maintenance problem. Most of the lawn areas are clover, with significant weed growth as well.

Curb Appeal	Excellent
Access	Excellent
Playground	Poor
Site Furnishings	Fair
Signage	Fair
Landscaping	Very Good
Lawns	Poor
Tennis	Fair
Ball Field	Poor
Soccer	Good
Sled Hill	Good
Trails	Very Good

- 1 Remove ball field components, restore lawn and add soccer goals for neighborhood use
- 1 Undertake a program to re-establish turf grasses throughout the park
- 1 Naturalize low area behind tennis courts
- 2 Replace the playground and incorporate shade trees into the design
- 2 Remove tree branches overhanging tennis courts that litter surface
- 2 Rebuild two tennis courts, including new fencing, surface coating and equipment
- 2 Convert two tennis courts to volleyball and basketball
- 3 Replace and add bicycle racks
- 3 Replace benches
- 3 Add landscaping at park signs
- 3 Add water fountains
- 4 Explore utilizing sled hill to create performing arts venue/amphitheatre

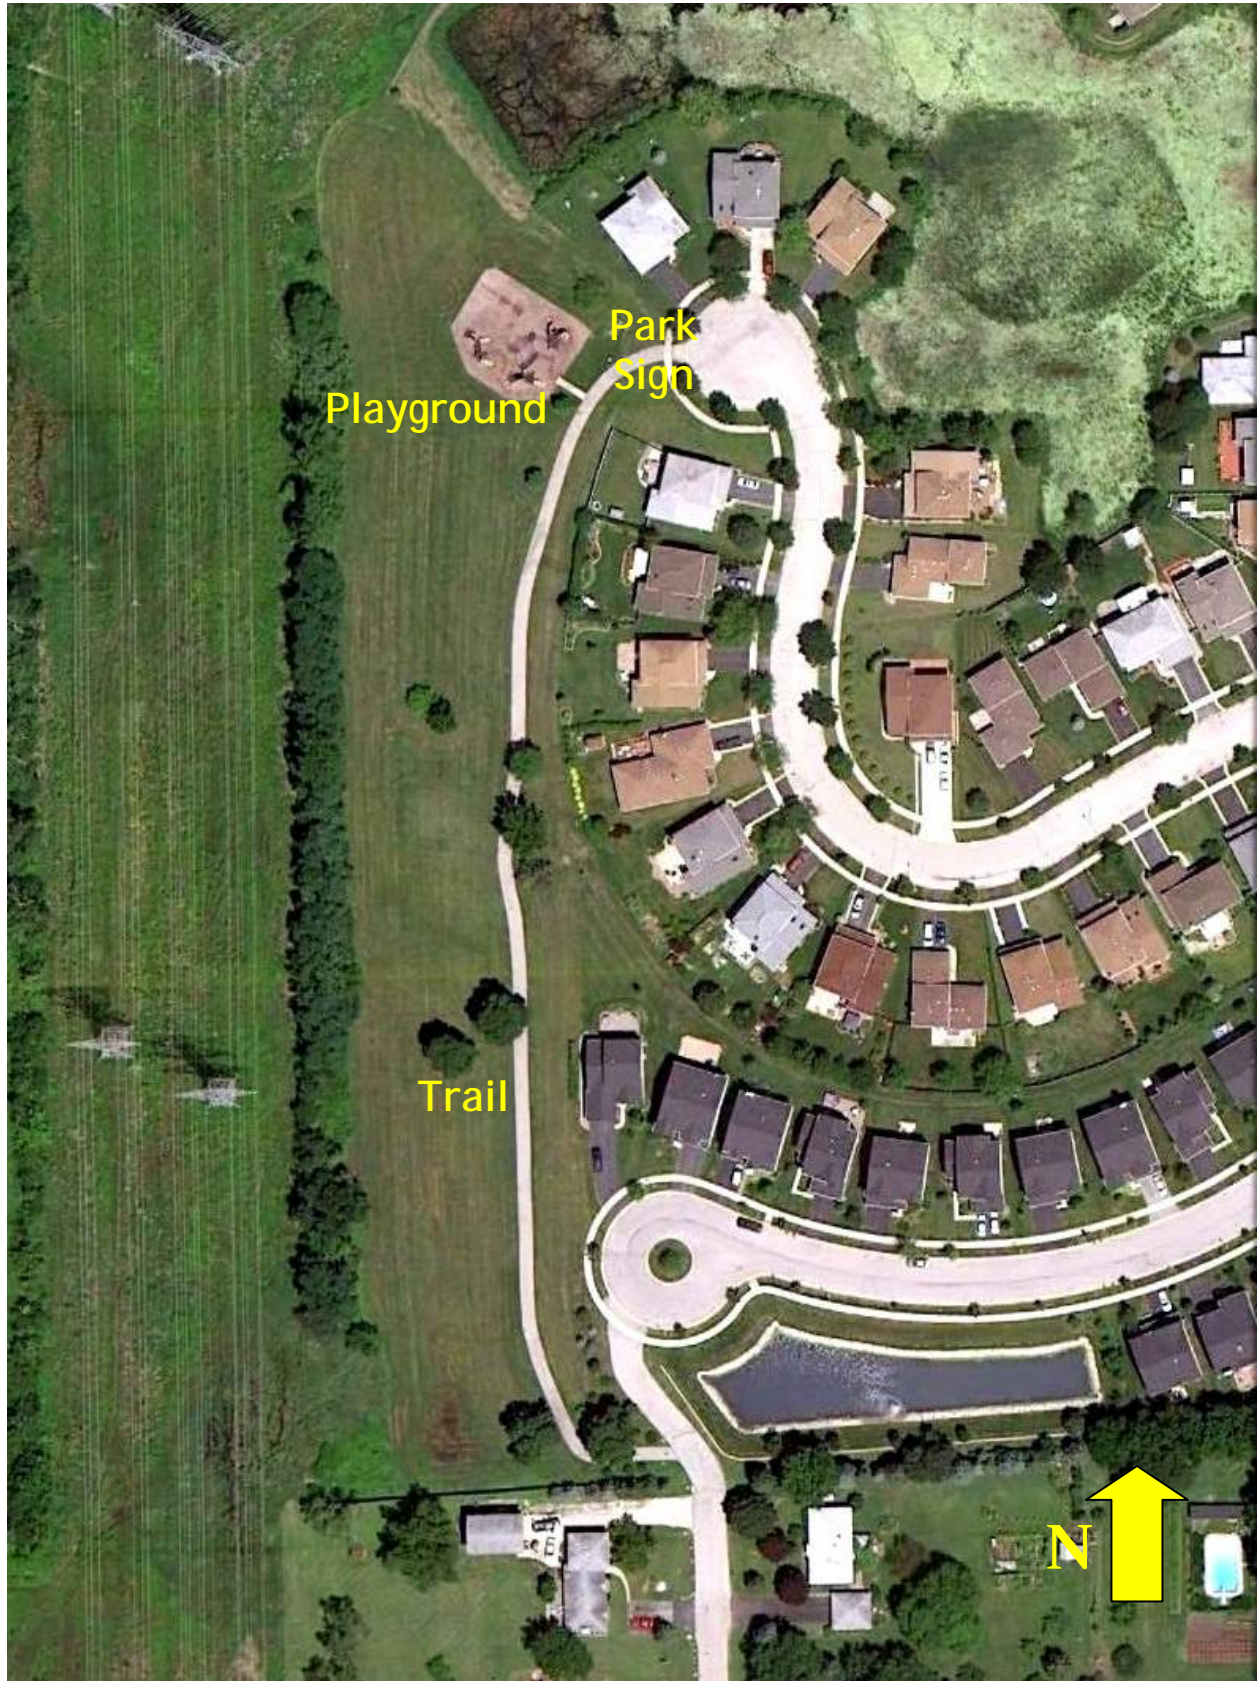
KENROY PARK

Curb Appeal	Fair
Access	Excellent
Playground	Very Good
Site Furnishings	Very Good
Signage	Good
Landscaping	Good
Lawns	Very Good
Trails	Excellent
Maintenance	Very Good

- 1 Replace barriers and warning signs with decorative fencing to control access, highlight park entries and make more visually inviting
- 1 Provide additional landscaping within the park, especially to highlight the park sign and entries.
- 2 Replace playground and incorporate shade trees into the design
- 2 Provide soccer goals that can be used for neighborhood pickup games
- 3 Add a bicycle rack
- 3 Add benches along the trail
- 4 Work with ComEd and FPDDC to provide access to the Swift Prairie Forest Preserve once any improvements and trails are provided within that preserve.

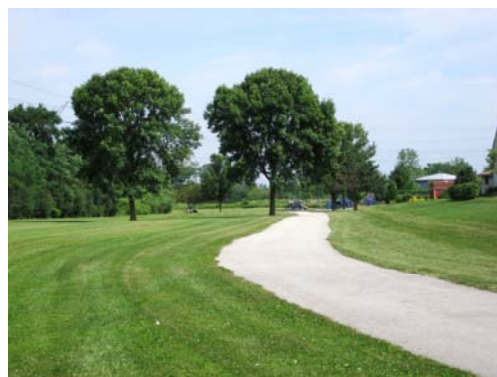
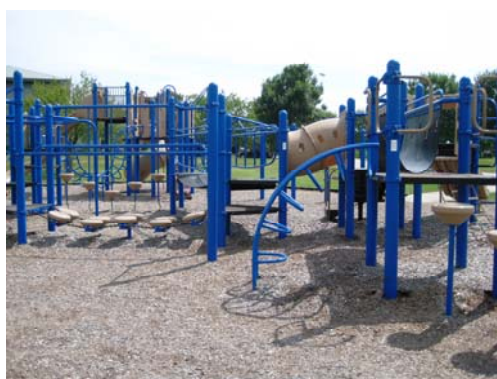
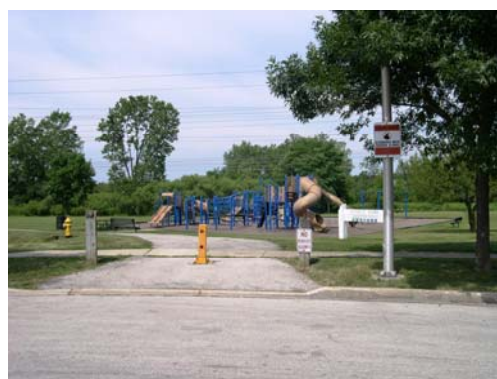
Kenroy Park, located in the far northwest corner of the community, is a small neighborhood park with limited amenities and serving a limited residential area. The park is bordered on the west by a ComEd utility corridor with the Swift Prairie Forest Preserve beyond. A fairly new and dense single-family residential area is east of the park, with older large-lot housing to the south. Access from the residential areas is easy, though parking is very limited in the residential areas. While the park address is Edward Drive, the formal entrance to the park is on the Cimarron Way cul-de-sac. Neither entrance is particularly inviting, as the south entrance is non-descript and the north entry has barricades and signs that clutter the view into the park. The playground is 12 years old, but is still in very good condition. Site furnishings vary in style and are limited. The trail connecting the north and south entrances is a winding path in excellent condition. Open lawn areas are virtually unused. A limited number of shade trees are well-placed along the trail.
