8 Park Assessment

PARK EVALUATION CRITERIA

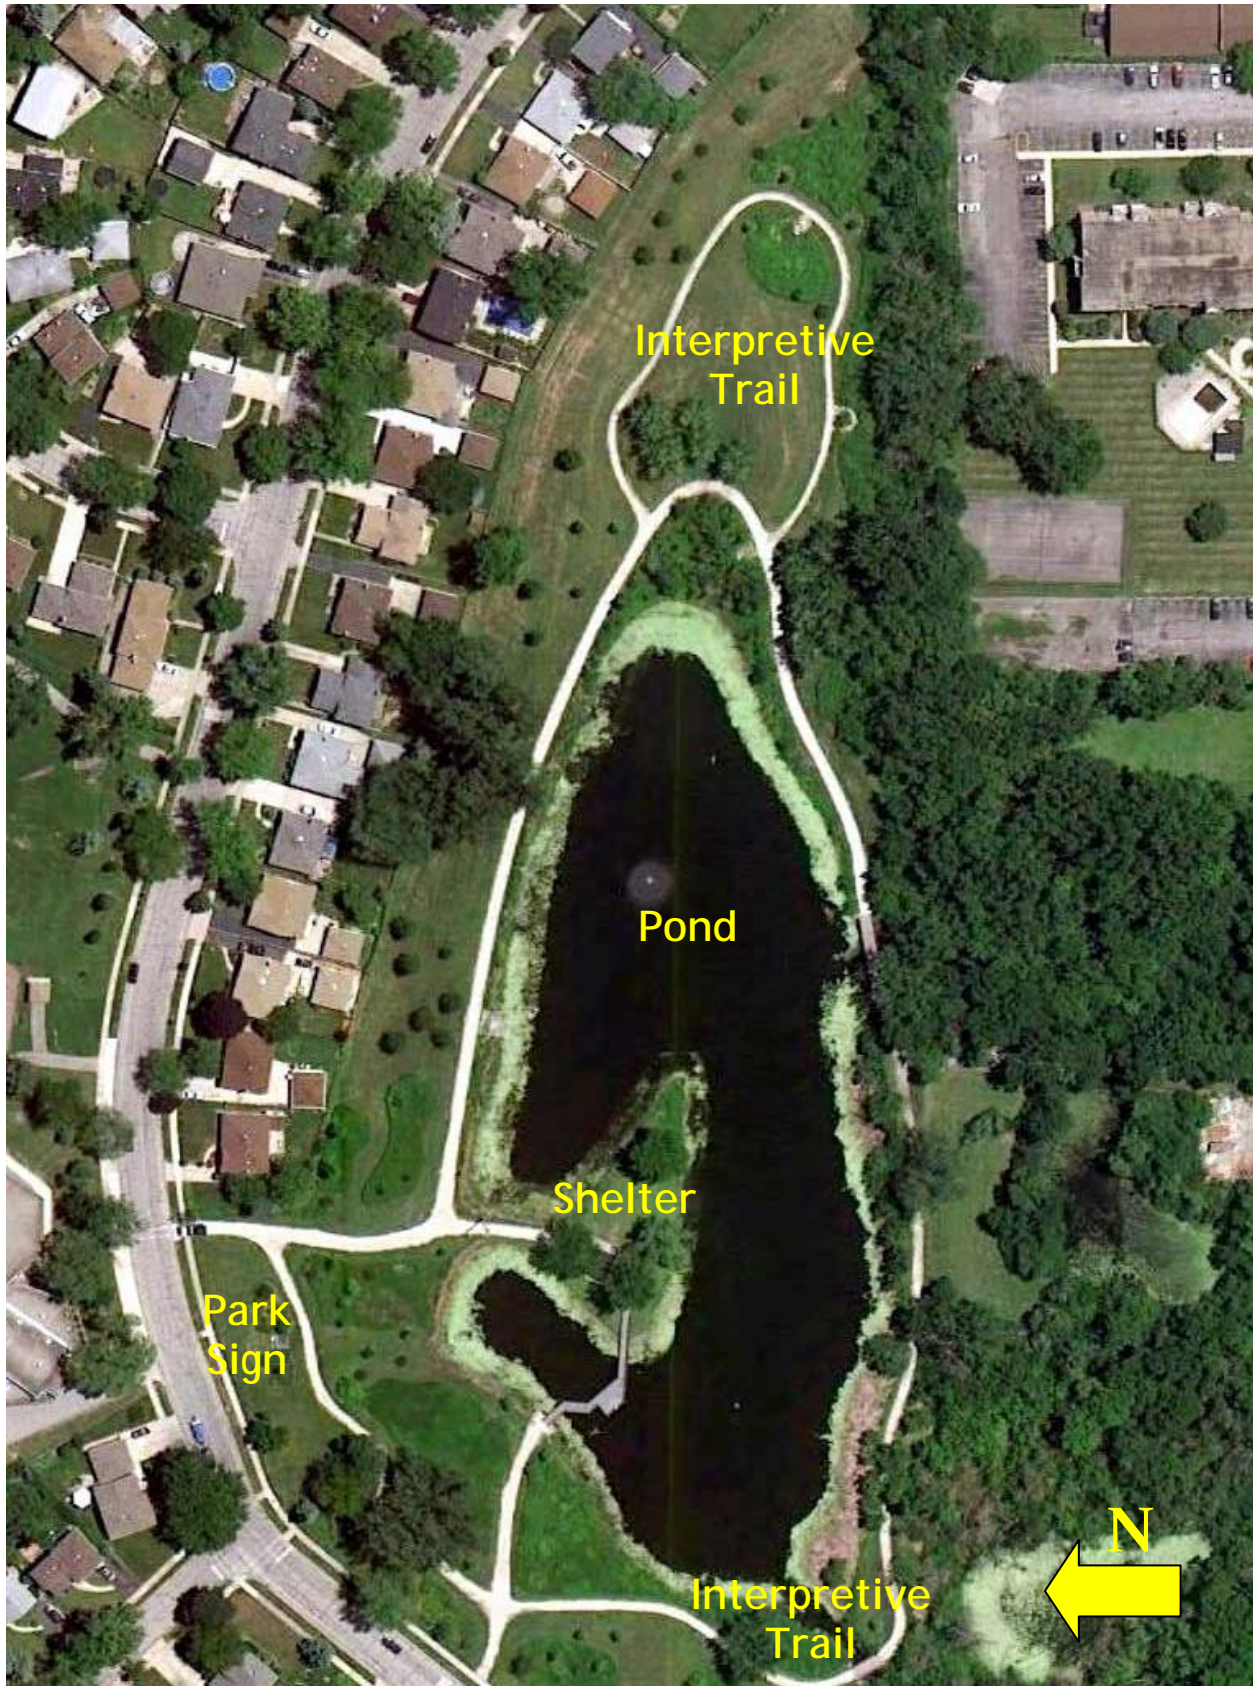
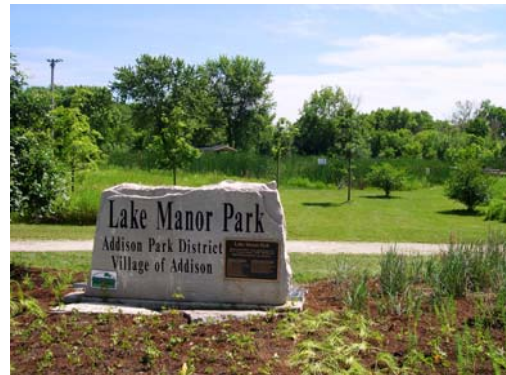
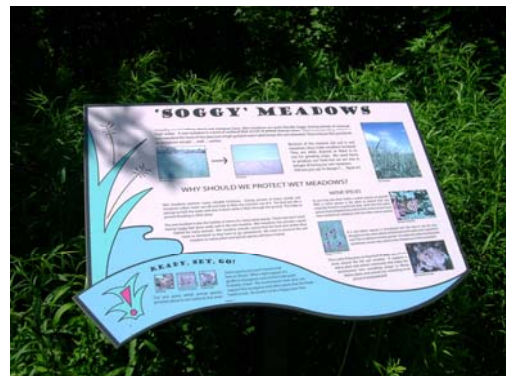
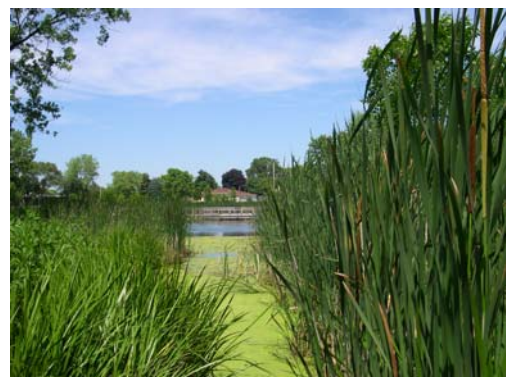
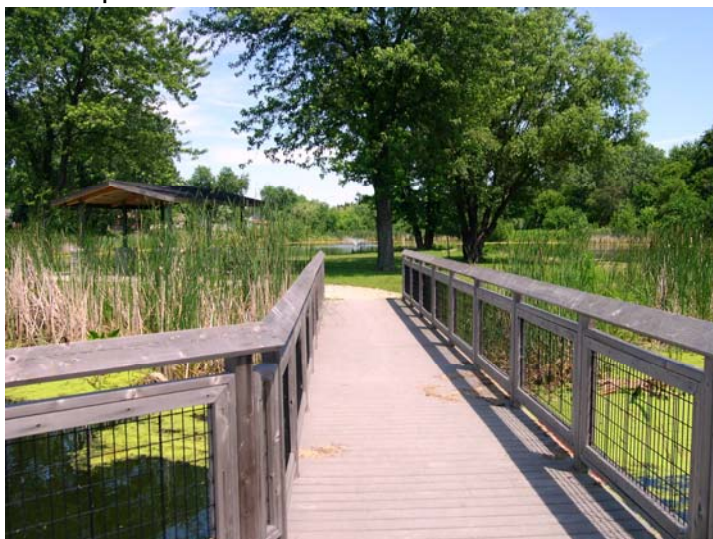
LAKE MANOR PARK

Lake Manor Park is an Open Lands park that provides passive recreation, open space and environmental education opportunities for community residents. The surrounding land uses are mostly single family residential, with some office and commercial to the south along Fullerton, including the APD planning and maintenance offices. The park is accessible to pedestrians from two locations along Lake Park drive, with on-street parking available. The trail into the park is somewhat steep. The park has a series of gravel trails that wind through a variety of different habitats, including wetlands, prairie and woodland. Interpretive signage provides educational information about the habitats. Bridges and boardwalks provide great overlooks, and a small shelter is a great place to relax and enjoy the surroundings. Benches are located at key locations along the trail. Some of the trail is lighted, though the style of lighting seems very out of character with the park. Lawn areas seem out of place in some locations as well.

Curb Appeal	Excellent
Access	Good
Site Furnishings	Good
Signage	Very Good
Interpretive Signs	Excellent
Landscaping	Excellent
Natural Areas	Excellent
Shelter	Excellent
Lawns	Fair
Trails	Excellent
Maintenance	Very Good

- 2 Convert turfgrass areas within the park to native prairie plantings in most areas where grass exists
- 2 Add a bicycle rack

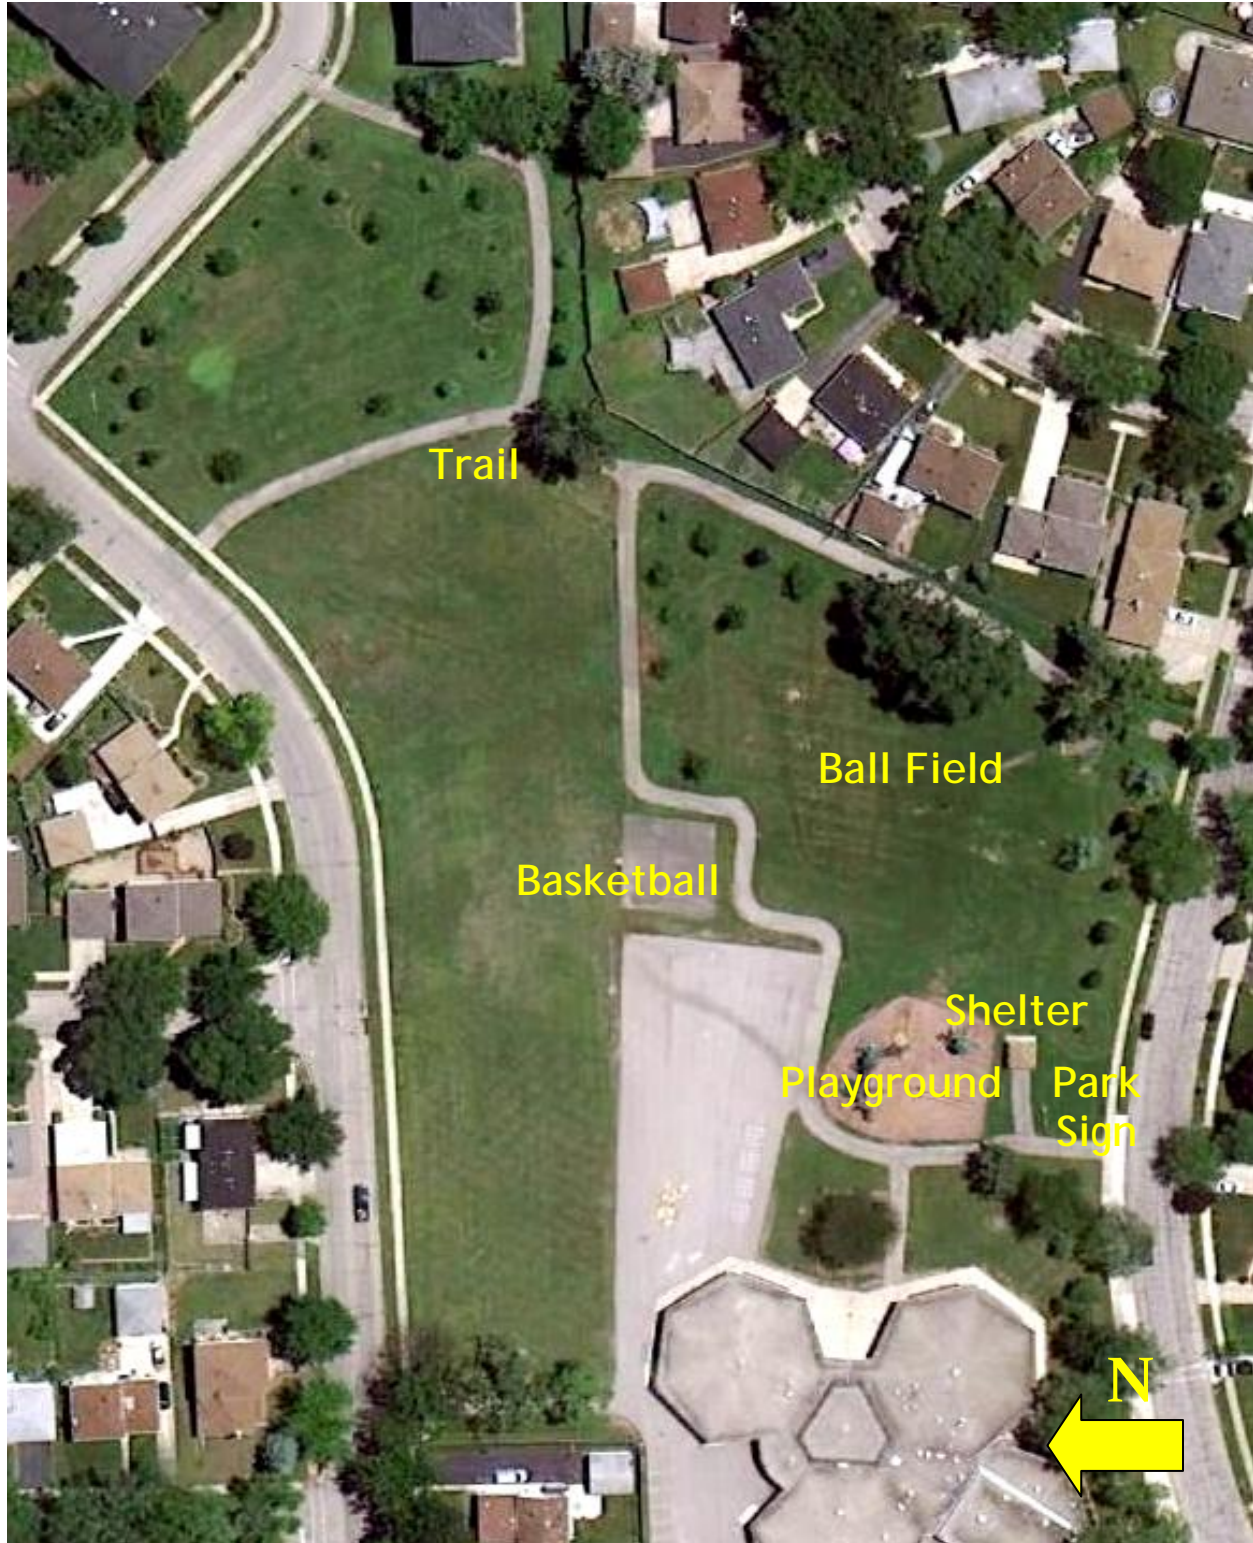
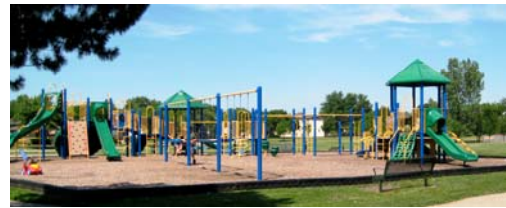
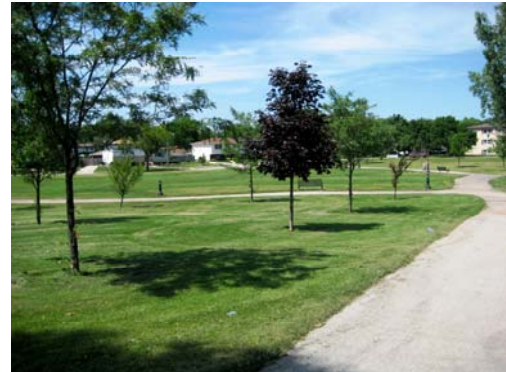
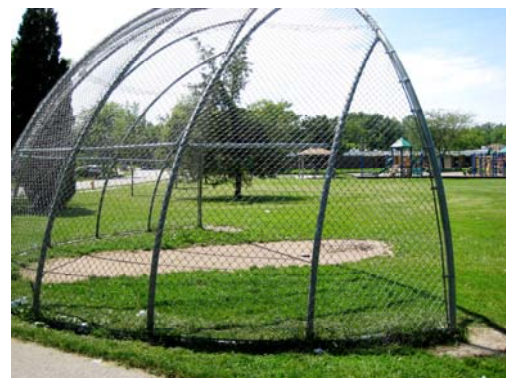
LAKE MANOR NORTH

Lake Manor North Park is a nice neighborhood park adjacent to Lake Park Elementary School and with single and multi-family residential to the north, south and east. Access to the park is excellent, with public sidewalks along the streets and four entry points, plus school lot access, into the park. The playground, constructed in 2002, includes an excellent variety of play features plus swings and other features. The playground gets a lot of use because of the school, but is holding up relatively well. The shelter is relatively new and provides a shaded picnic area. There is a culvert under the trail that has heaved up during the winter and caused significant cracking of the trail surface. The northeast corner of the park has been planted with shade trees and may make a nice passive area in the future. Other areas of the park could use more landscaping, especially at the sign. The lawn areas have a good amount of clover mixed in with turfgrasses.

Curb Appeal	Excellent
Access	Excellent
Playground	Good
Site Furnishings	Very Good
Signage	Very Good
Landscaping	Good
Lawns	Good
Ball Field	Good
Shelter	Excellent
Trails	Very Good
Maintenance	Very Good

- 2 Replace Chicago-style backstop with more traditional backstop/fencing
- 2 Rebuild the culvert under the trail and repair paving
- 3 Add shade trees throughout the park, especially at the playground area and as shade for the benches
- 3 Provide landscaping at appropriate places within the park, especially to highlight the park sign

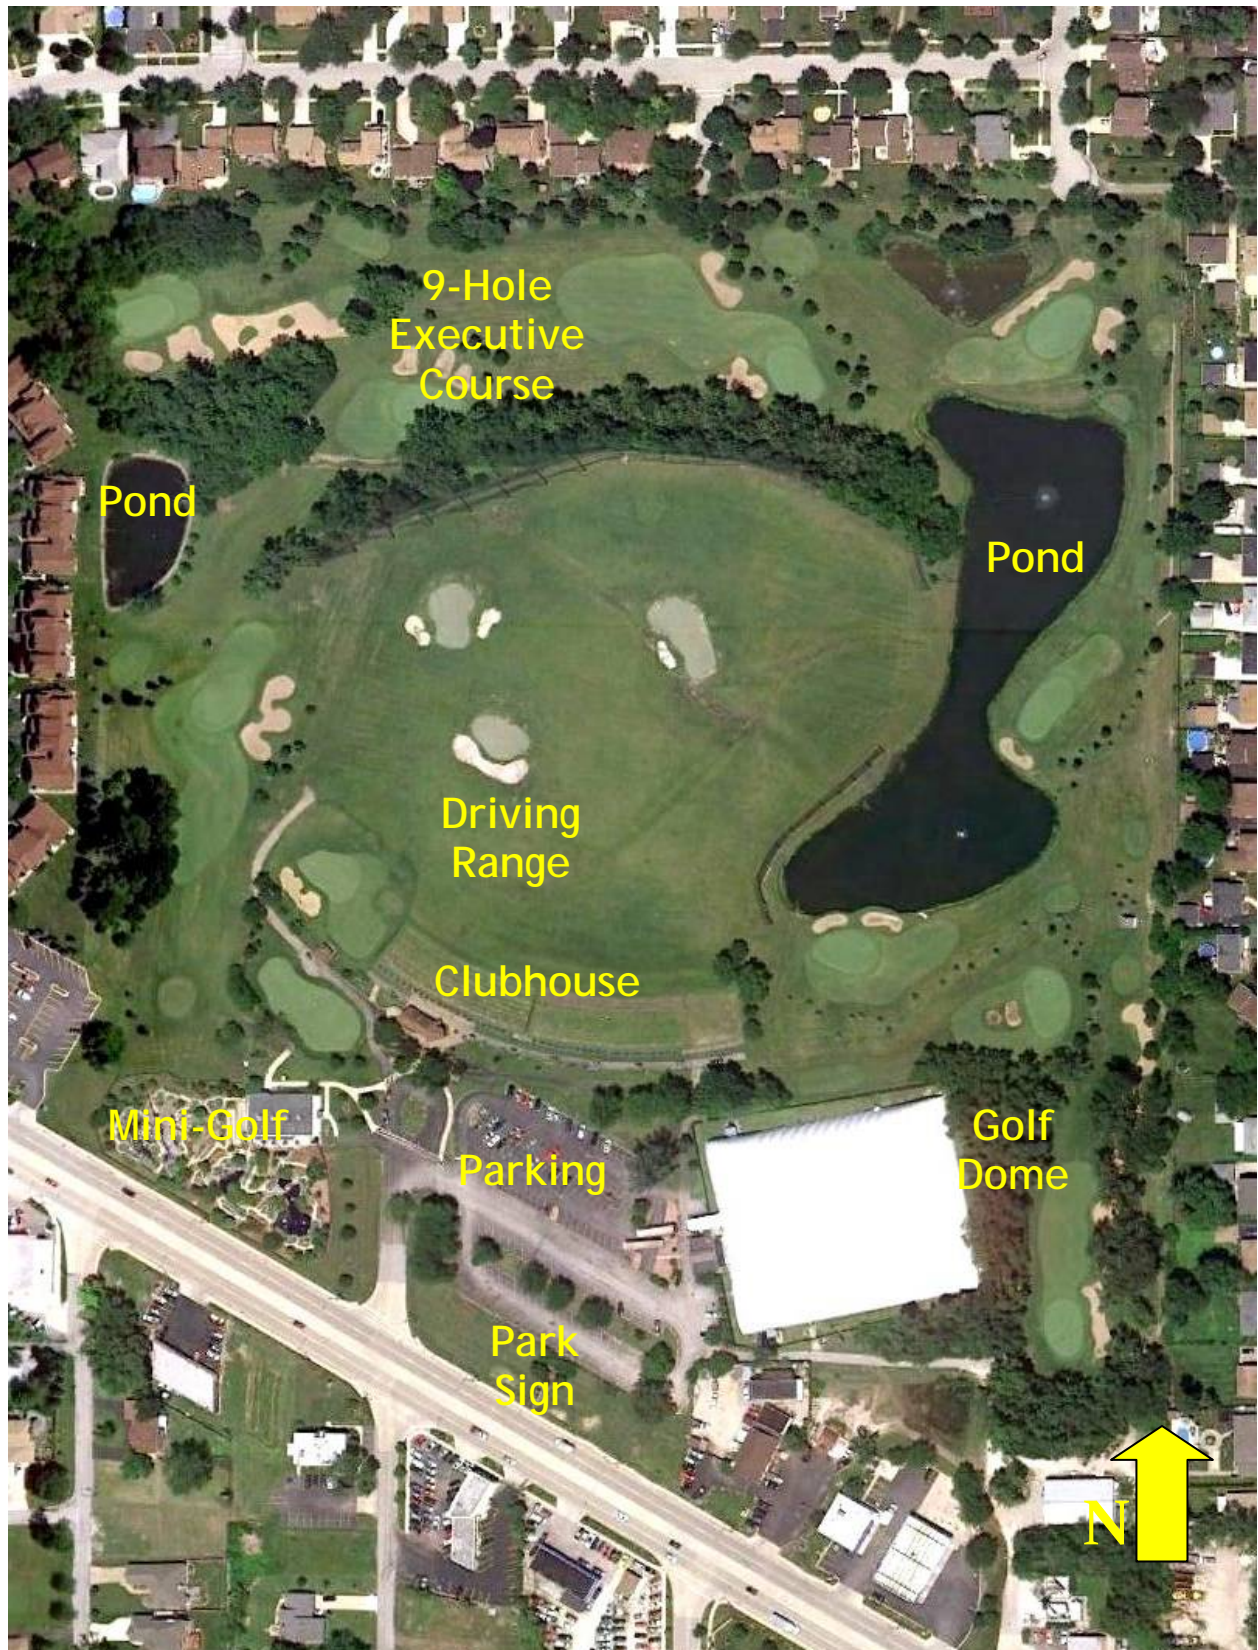
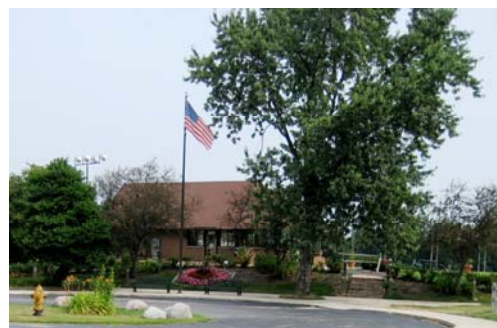
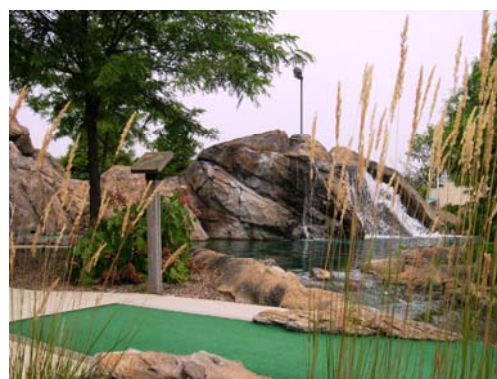
LINKS & TEES

Links & Tees is the District's one Special Use Park, and one of the most used parks in Addison, with a variety of golfing facilities. The facility, centrally located on Lake Street, has an inviting appearance from the street as a well-landscaped buffer separates the large parking area from view. There are sidewalks along Lake Street, but Links & Tees is a destination to which most people drive; though some patrons do bicycle to the facility. The 9-Hole Executive Par 3 course, at just over 1100 yards, is one of Golf Range Magazine's "Top 100 Golf Practice Facilities." The well-maintained course can challenge all levels of golfer. There is a small pro shop that provides a good variety of products and services. The Practice Range has over 50 hitting stations, a pitch and putt area and a practice green. Putter's Peak Miniature Golf Course is a nice family attraction with 18 holes that are relatively easy, but in a setting with water features and good landscaping. The 4,000 s.f. Clubhouse provides a place to relax after golfing activities, offering concessions, party rooms and various other activities. During the winter months, the Golf Dome offers indoor practice facilities and private lessons. Landscaping around the activity hub is great in some places and poor in others.

Curb Appeal	Very Good
Access	Good
Site Furnishings	Very Good
Signage	Excellent
Landscaping	Good
Lawns	Good
Executive Course	Very Good
Practice Range	Very Good
Mini-Golf	Very Good
Maintenance	Good

- 1 Redesign the landscape at the Golf Dome to provide winter interest
- 1 Redesign entry drive/drop-off/parking access to provide safe and easily understandable traffic patterns
- 1 Landscape the drop-off island to provide seasonal interest
- 1 Repave parking lot
- 1 Replace target greens
- 1 Renovate clubhouse to add food services and shade canopy
- 1 Renovate the parking lot and buffer area landscape
- 1 Add a bicycle rack at Clubhouse
- 3 Add grasses and perennials in Putter's Peak to provide color and textural diversity
- 3 Add phase two driving range

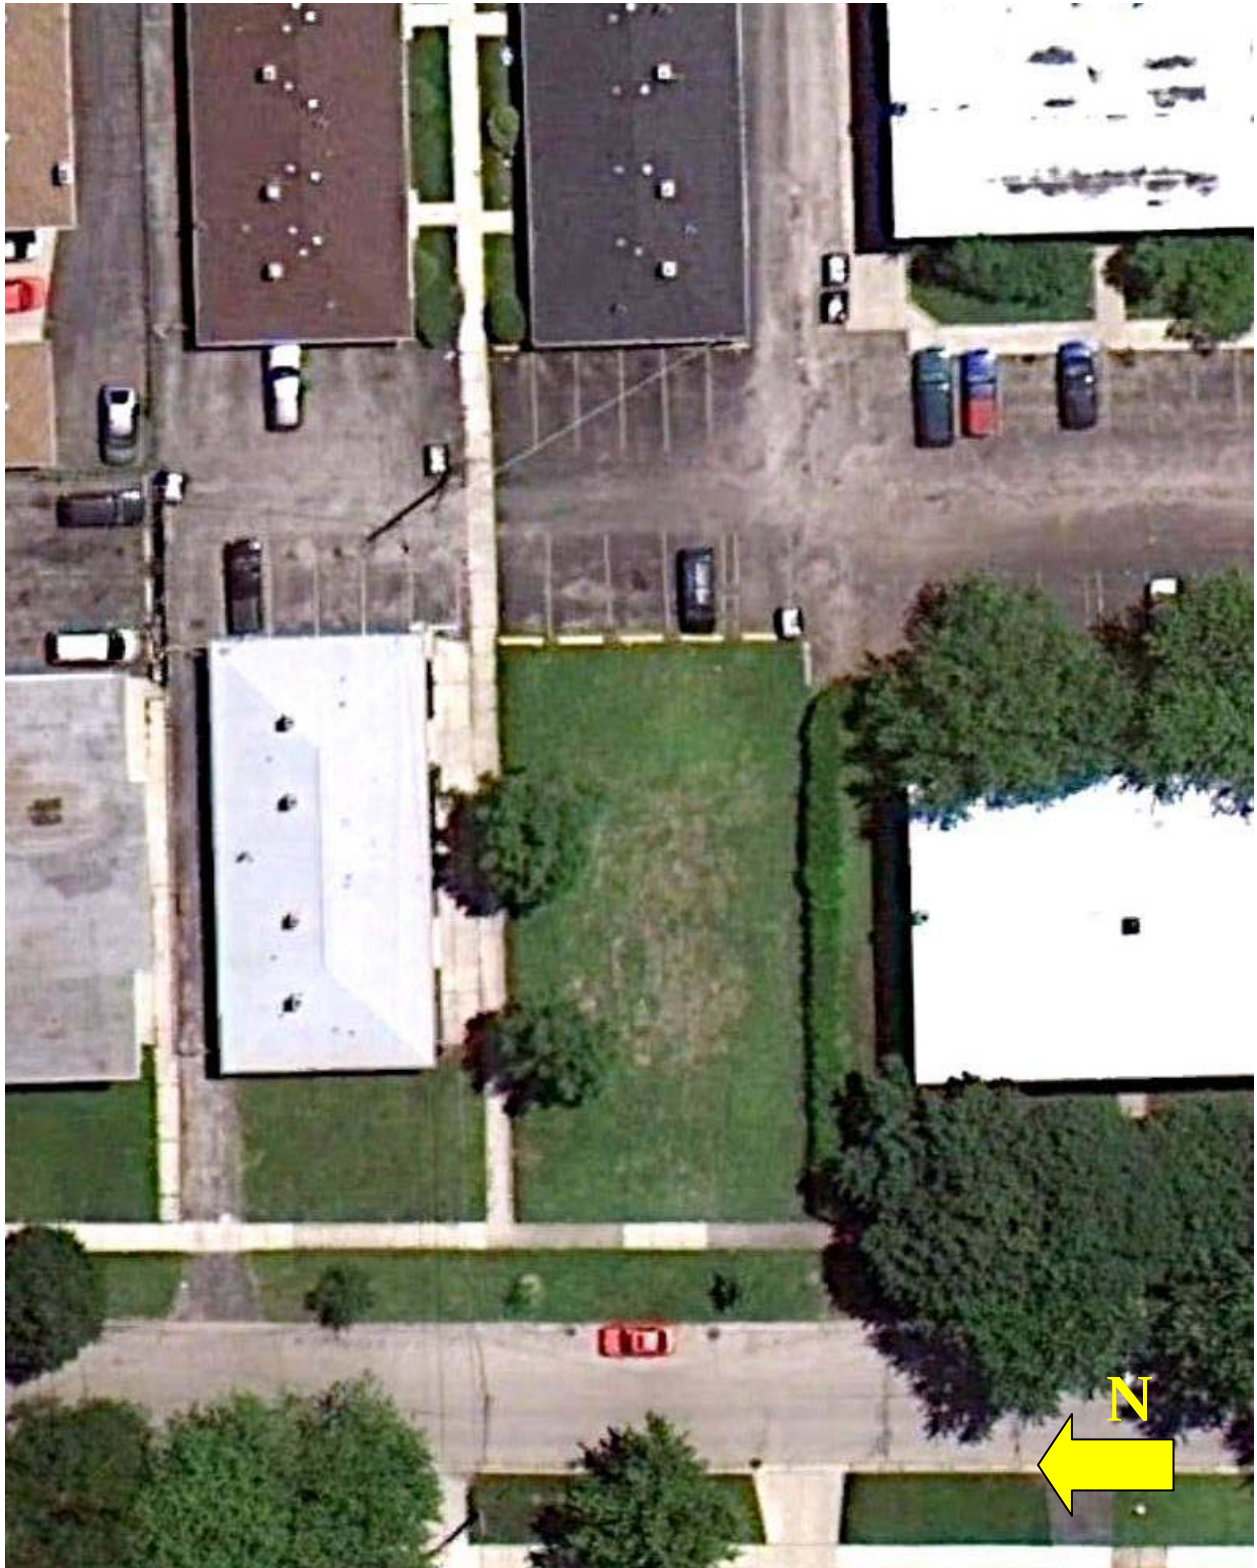
MAY STREET TOT LOT

The May Street Tot Lot playground structure was burned down in 2007 in an act of vandalism. The park property is surrounded by single and multi-family housing, with sidewalks providing easy access to the perimeter of the park. There is no park sign, and only two benches and trash barrel are provided as amenities. A few trees exist on the site and provide some shade. The lawn areas are a mix of turfgrasses, clover and weeds. Because the site is so small, a new playground is not feasible as current safety guidelines for fall zones preclude any equipment from fitting on the site.

Curb Appeal	Poor
Access	Very Good
Site Furnishings	Very Good
Signage	Poor
Landscaping	Poor
Lawns	Poor
Maintenance	Fair

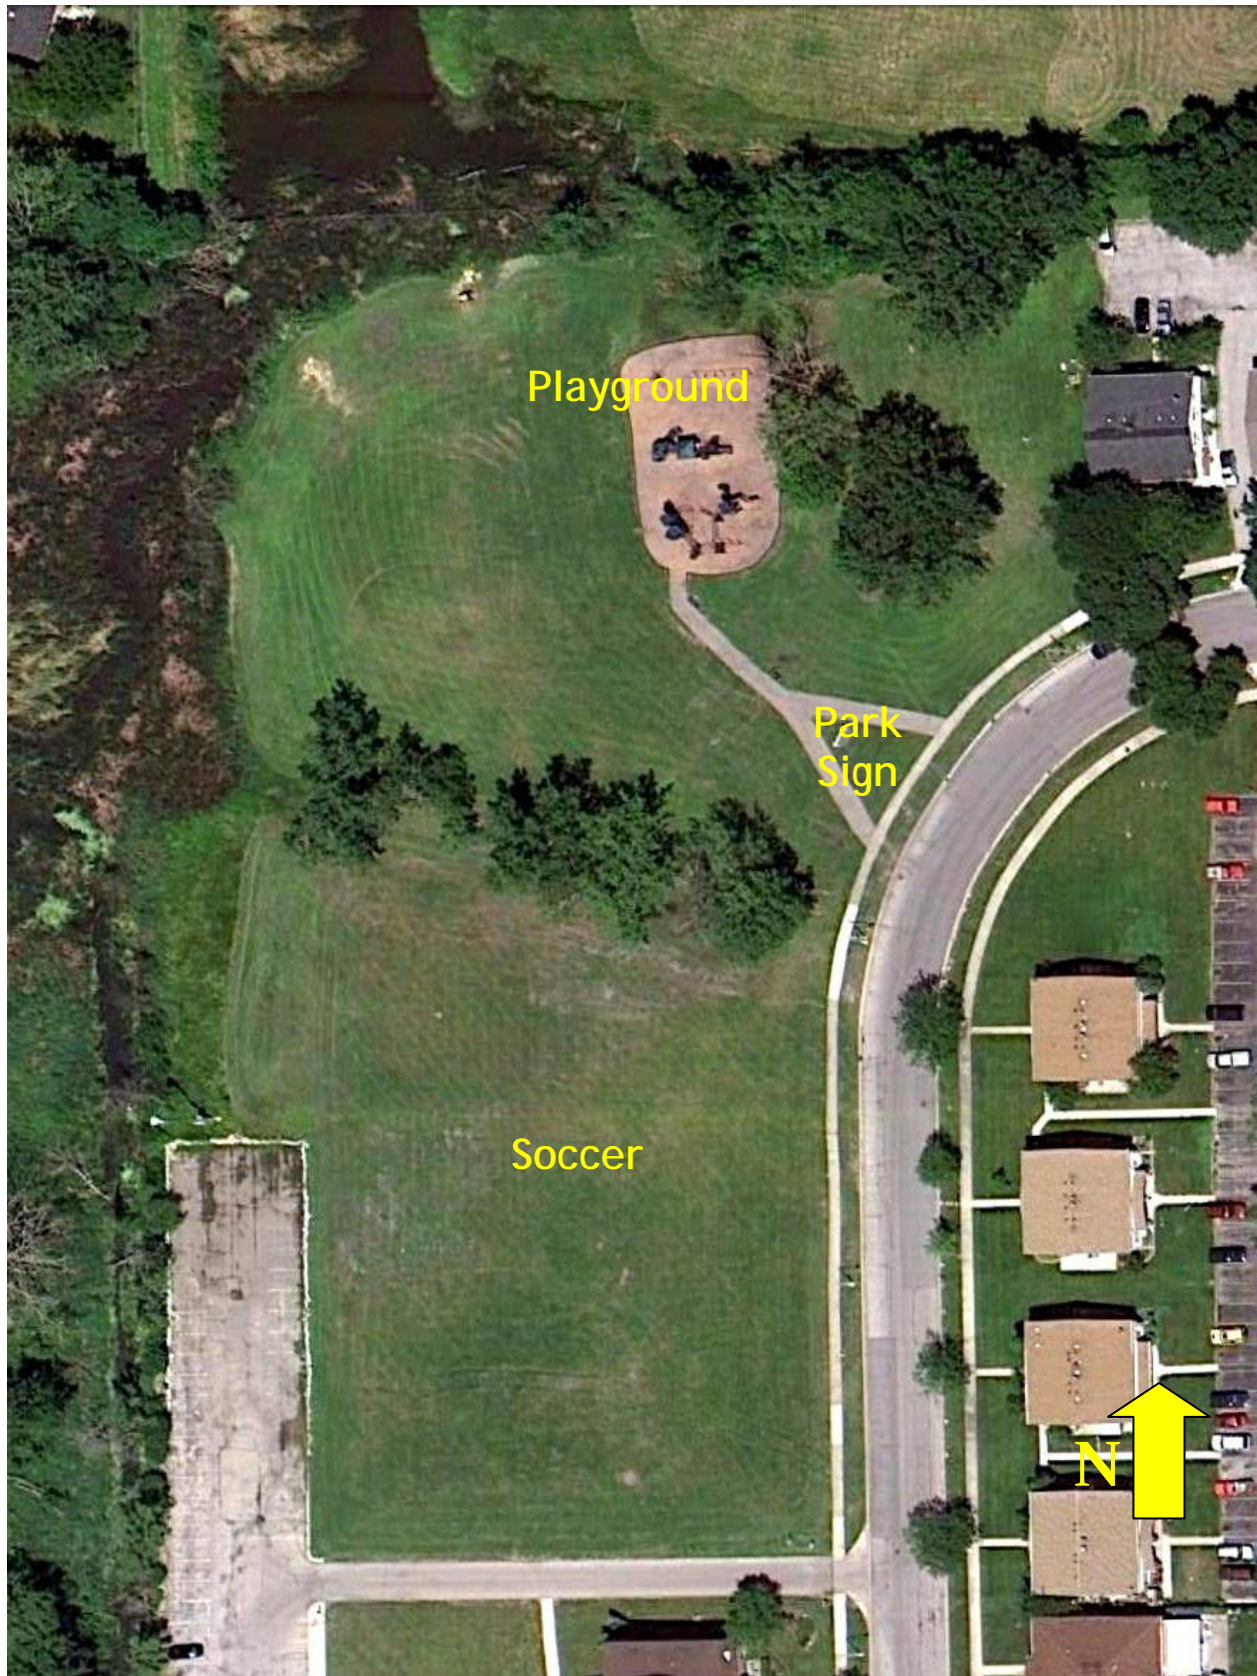
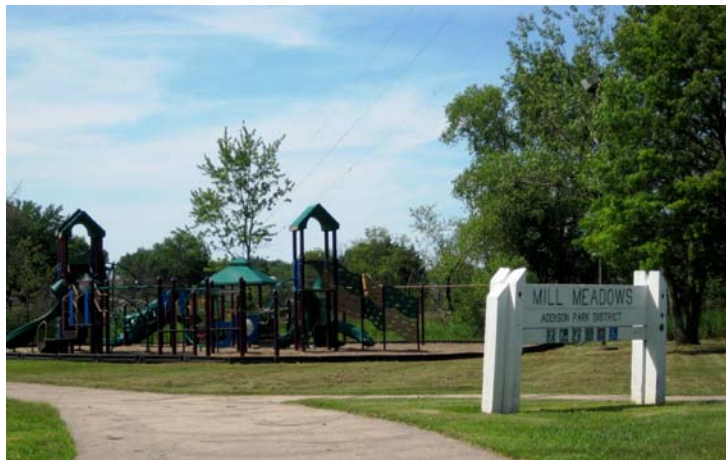
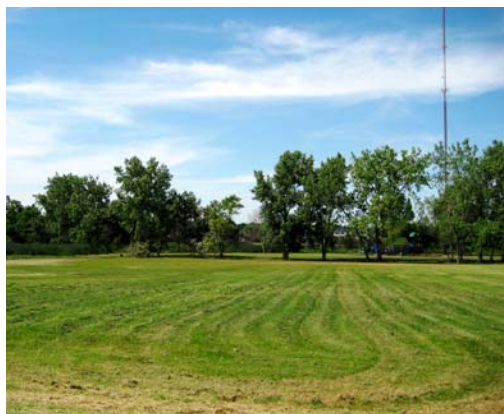
MILL MEADOWS PARK

Mill Meadows Park is a small neighborhood park servicing a limited area of single and multi-family housing. Bordered on the west by a naturalized stormwater management area with light industrial beyond, the park is prone to some flooding. There is a public sidewalk along the entire front of the park to provide neighborhood access. There is a deteriorated parking area behind the park, but it is owned by the adjacent apartment complex. The park is generally inviting from the street as open space. The park sign is in need of replacement and landscaping. The playground is relatively new, constructed in 2006, and offers a good variety of features. Graffiti is a problem on the playground. There is one bench and security lighting at the playground. The soccer field is small and can be used for either organized games or neighborhood pick-up games. A hedgerow of trees and a drainage swale separate the soccer field from the rest of the park site. There are shade trees near the playground, but only provide shade on the structure in the early morning. There is no landscaping within the park, and much of the lawn areas are clover and weeds. Infrequent mowing and wetness have caused rutted areas in the lawn and much thatch after mowing.

Curb Appeal	Good
Access	Very Good
Playground	Excellent
Site Furnishings	Good
Signage	Fair
Landscaping	Fair
Lawns	Fair
Soccer	Fair
Trails	Very Good
Maintenance	Fair

- 1 Add a bicycle rack
- 2 Replace park sign
- 2 Provide additional landscaping within the park, especially to highlight the park sign
- 3 Add shade trees at the playground area
- 3 Add a half-court or three-point line basketball court
- 3 Provide path to soccer field from playground area

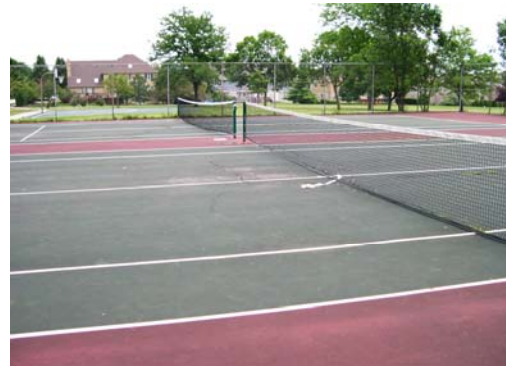
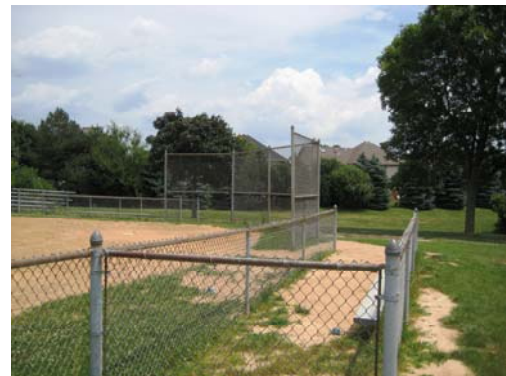
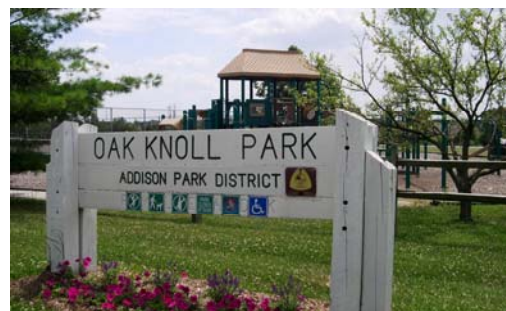
OAK KNOLL PARK

Curb Appeal	Good
Access	Fair
Playground	Fair
Site Furnishings	Fair
Signage	Good
Landscaping	Good
Lawns	Fair
Ball Fields	Fair
Cricket	Good
Tennis	Fair
Basketball	Good
Parking	Very Good
Maintenance	Good

- 1 Redesign the trail to meet ADA standards
- 1 Replace playground
- 1 Move and screen port-a-potty
- 1 Renovate ball fields, including replacement of ball field fencing and backstop, new dugout and bleacher pads with walkways, adding infield mix and re-edge infield
- 2 Undertake a program to re-establish turfgrasses throughout the park
- 2 Renovate tennis courts, including new fencing, new nets, resurfacing/color & player bench
- 2 Resurface basketball court
- 2 Replace benches
- 2 Add park sign at parking lot
- 4 Work with the Village to provide crosswalks to Forest Court and Cardinal Avenue
- 4 Develop trail loop through wooded area

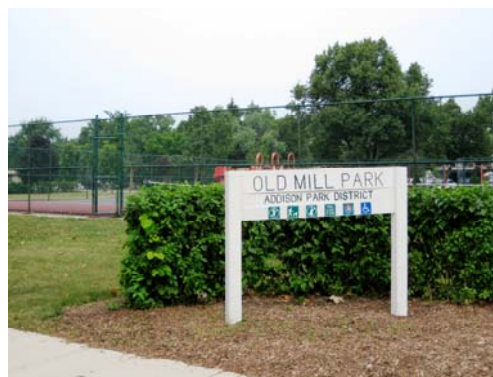
OLD MILL PARK

Old Mill Park is a small neighborhood park completely surrounded by a single-family residential neighborhood. The park has an inviting look, and is easily accessible by public sidewalks on three sides of the park. The park has a limited number of recreation amenities due to its size. The large playground area is at the end of its lifecycle and in need of replacement. A split-rail fence along the playground is a nice aesthetic and safety feature, but needs to be reset to vertical. The tennis court surfaces have some minor cracking and the vinyl-coated fencing is in relatively good condition considering their age. Picnic tables and benches have had minor vandalism, but are still serviceable. There are a variety of trees and shrubs in the park, especially around the perimeter. There is an open lawn area that can be used for a variety of activities. Most of the lawn area is clover.

Curb Appeal	Good
Access	Excellent
Playground	Fair
Site Furnishings	Fair
Signage	Good
Landscaping	Good
Lawns	Fair
Tennis	Fair
Maintenance	Good

- 1 Replace playground and add accessible path from public sidewalk
- 1 Reset fencing
- 2 Undertake a program to re-establish turfgrasses throughout the park
- 2 Replace tennis courts with volleyball and basketball
- 2 Add a bicycle rack
- 2 Replace drinking fountain
- 2 Provide soccer goals that can be used for neighborhood pickup games
- 4 Re-establish ice capability

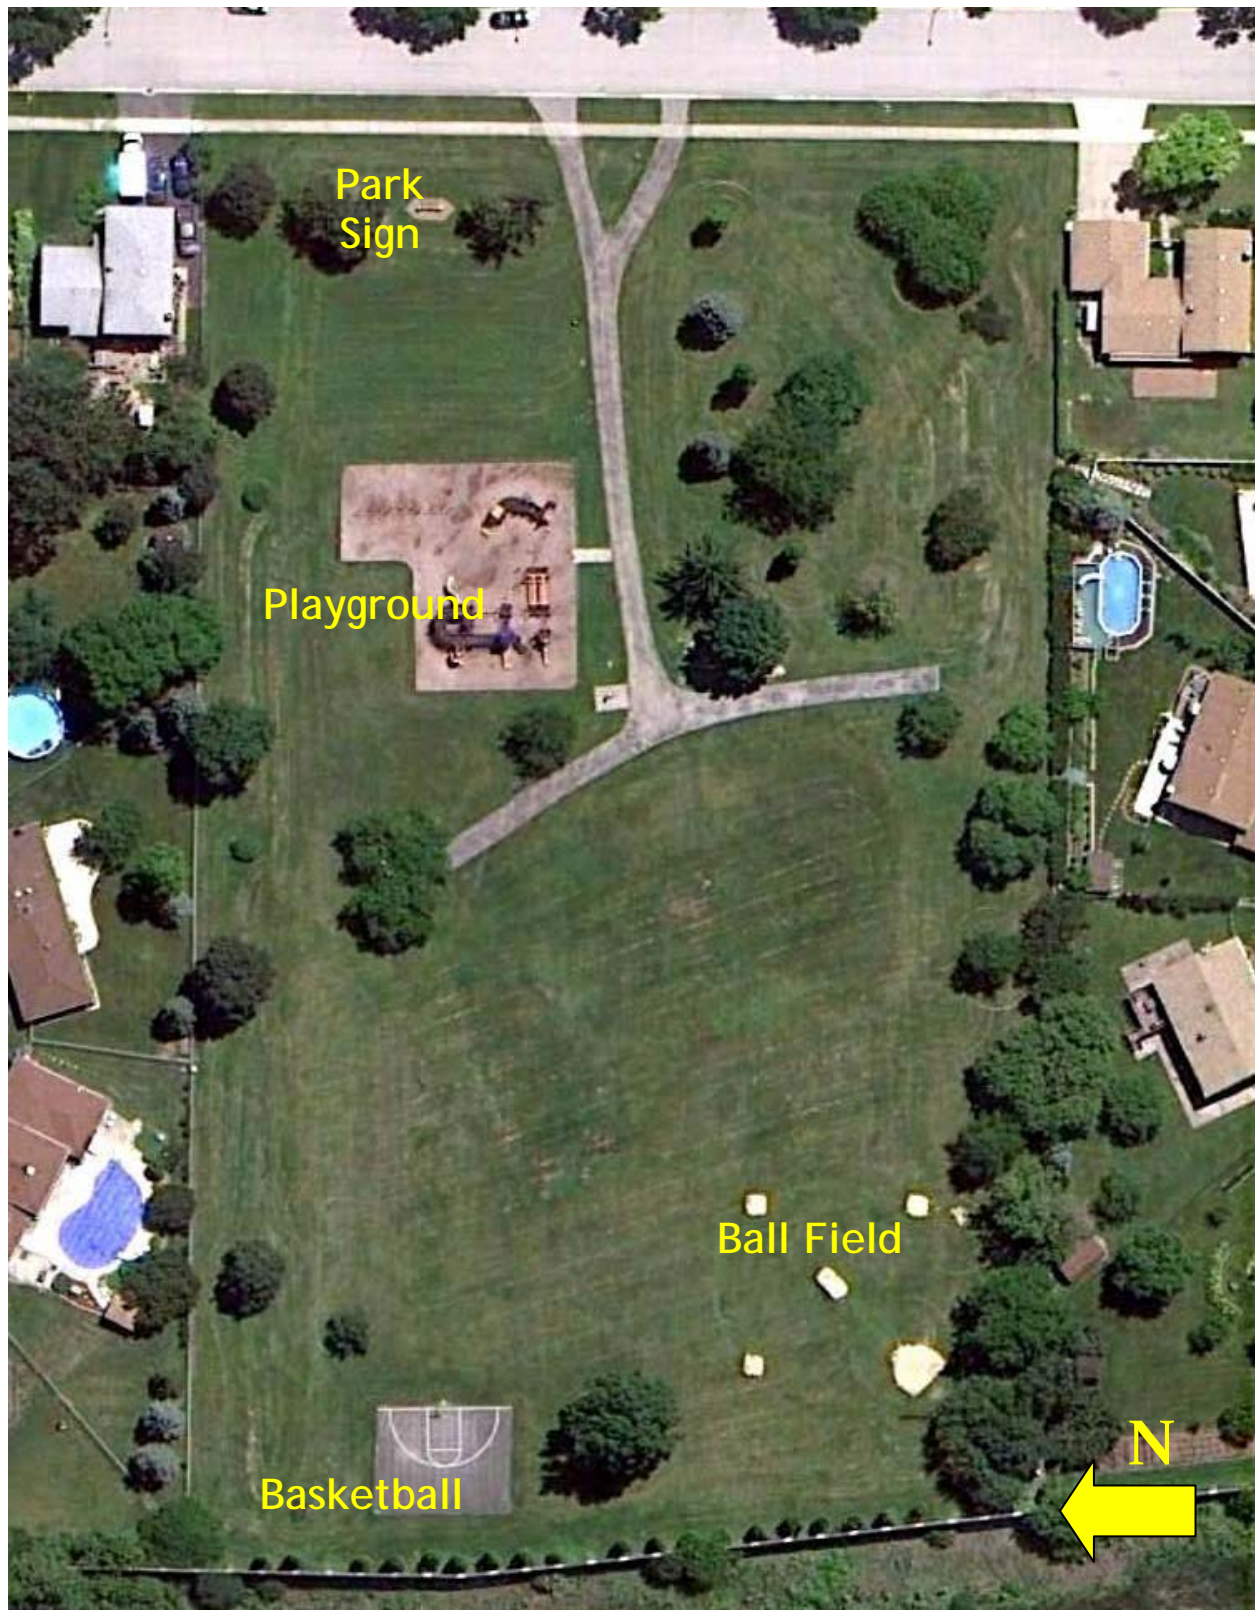
SUNSET PARK

Curb Appeal	Good
Access	Very Good
Playground	Fair
Site Furnishings	Good
Signage	Good
Landscaping	Very Good
Lawns	Good
Ball Field	Very Good
Basketball	Good
Maintenance	Good

- 1 Replace playground
- 1 Replace or paint basketball backboard
- 1 Add barrier fence off north side of basketball to prevent ball roll
- 2 Replace drinking fountain
- 3 Provide soccer goals that can be used for neighborhood pickup games

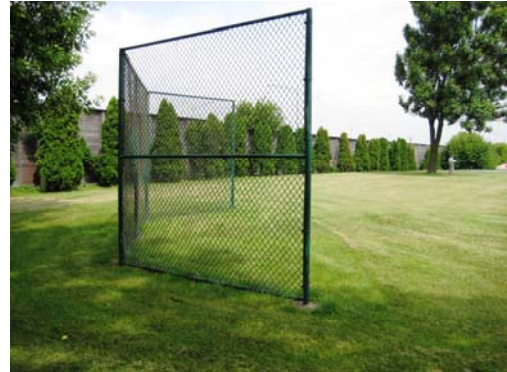
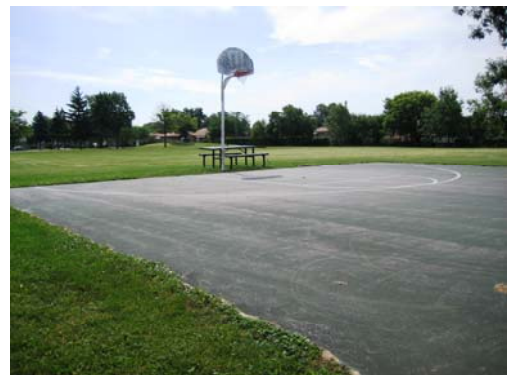
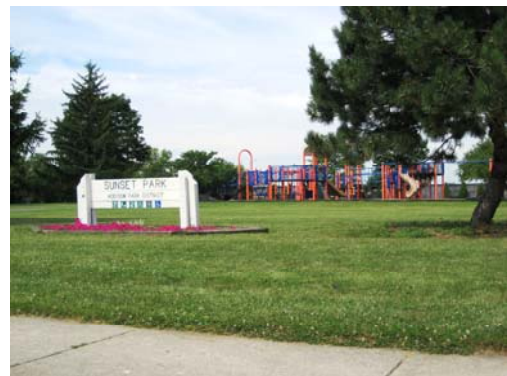
Sunset Park is a small neighborhood park located on the west side of the community, with single-family residential neighborhood on three sides and bordering on I-355 to the west. Even with a sound wall in place, there is a high level of ambient traffic noise. Access to the park is provided by a public sidewalk along Kenmore, with a trail entering the park site to the playground area. From the street the park looks inviting but dated due in large part to the faded playground colors. The relatively large playground does offer good variety, but is at the end of its lifecycle. The basketball court is located at the back of the park and has no access trail to the court. The court is in relatively good condition, but the backboard is rusted and needs to be painted or even replaced. The lawn on the north side of the court has a significant slope that allows a lost ball to roll 40' to the perimeter fence. A ball field backstop provides for neighborhood pick-up games on a field that is a mix of turfgrasses and clover. There are two ADA picnic tables, with only one on a paved accessible surface. Both tables have been deformed by bending the tables at the open end.

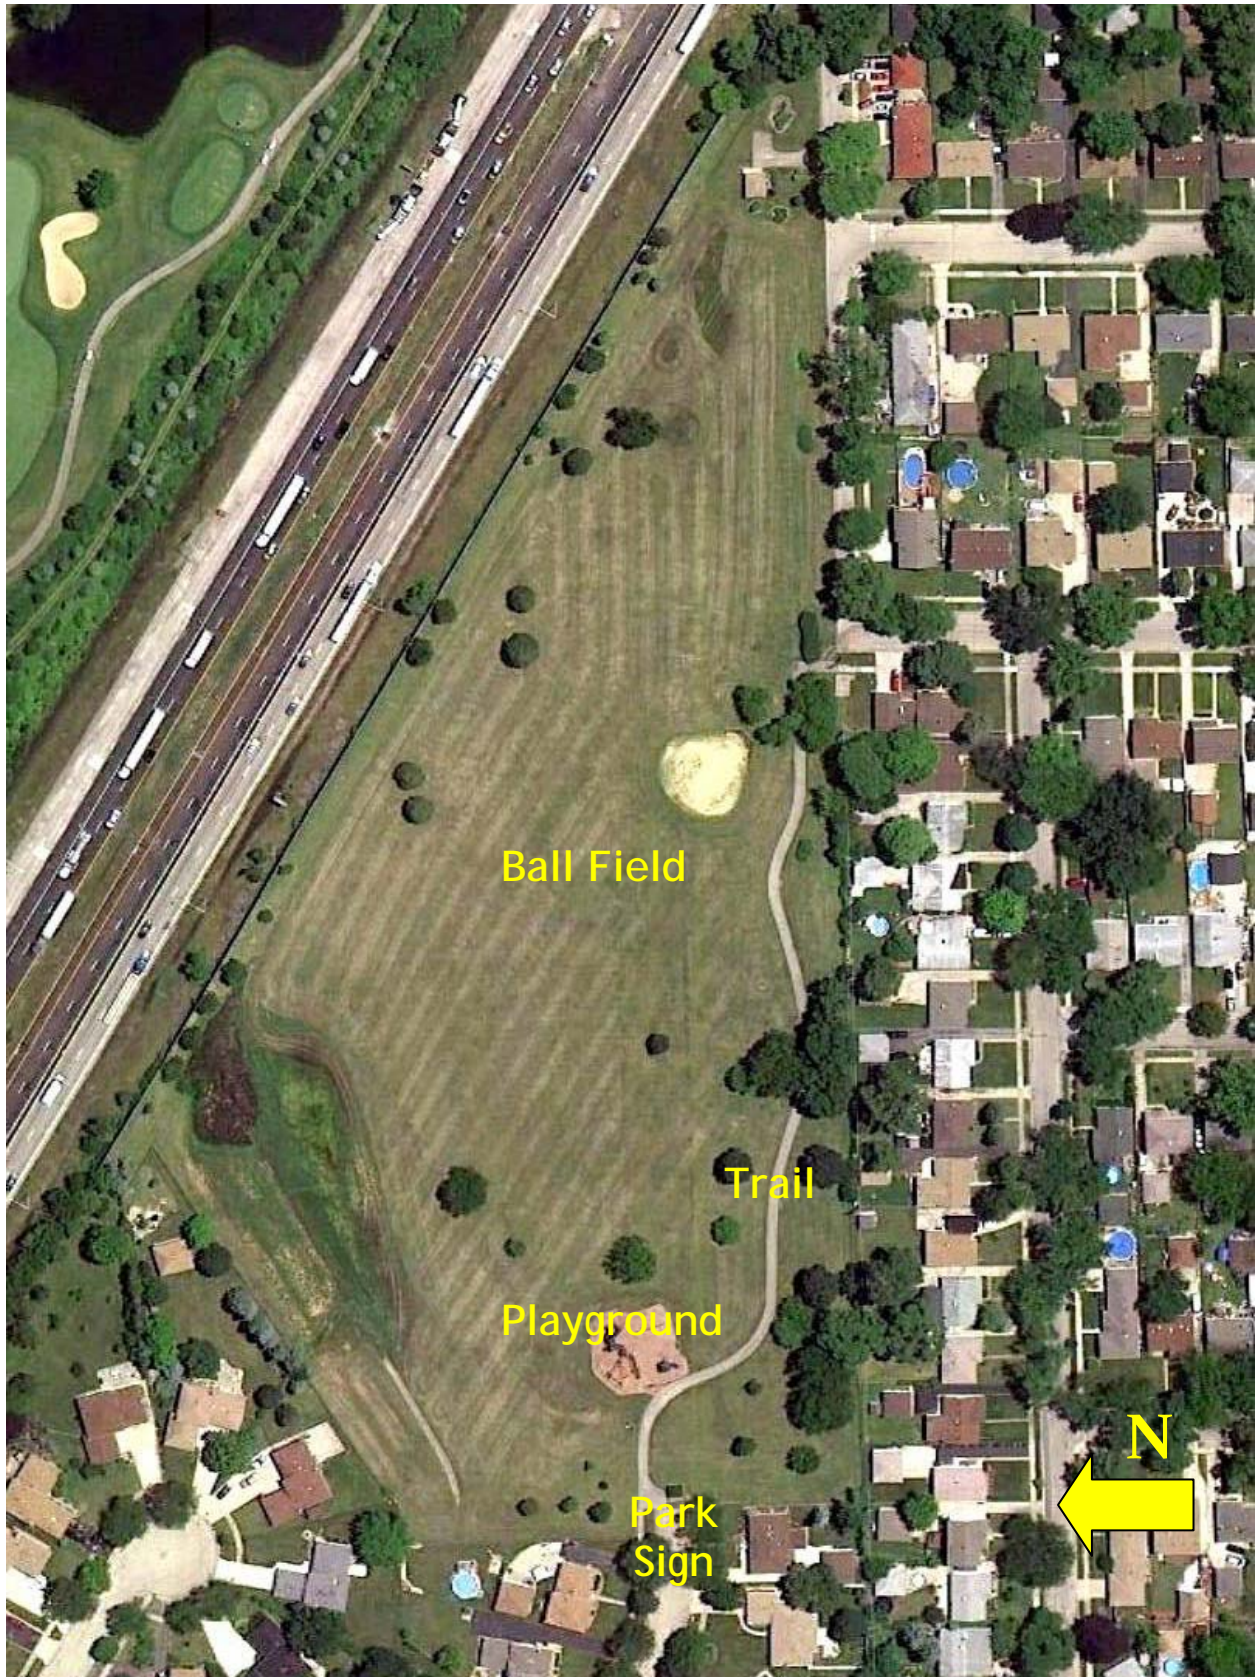
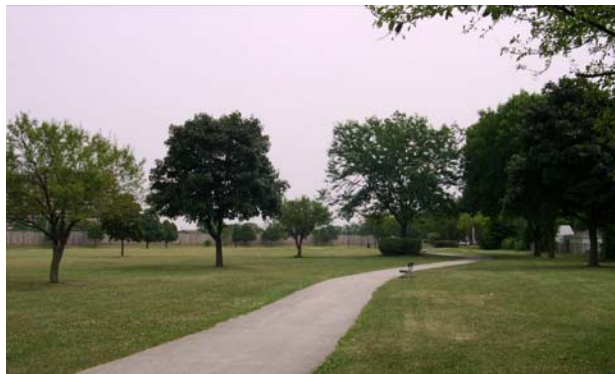
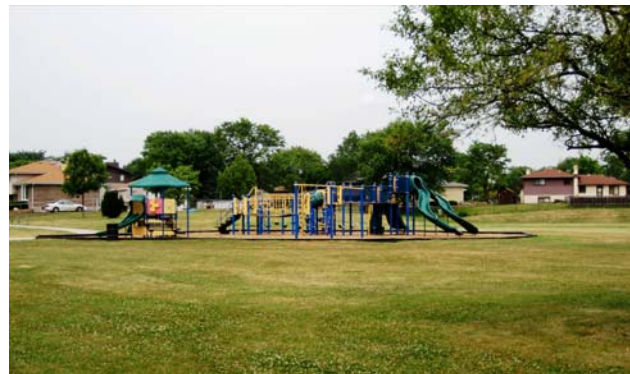
TAMARA HEIGHTS PARK

Tamara Heights Park is a relatively passive community park with a nice single-family neighborhood surrounding most of the park and with I-290 forming the northeast border. The park presents a nice open space image to the neighborhood, with access into the park from two locations on the west and south sides. The park sign is rotting, and the landscape in many areas of the park is over-maintained and in poor condition. There is, however, a nice mix of trees scattered throughout the park. The majority of the lawn areas are clover. The playground is still in relatively good condition, though will likely need to be replaced in a few years. The ball field, used for pick-up games, is in fair condition, with the infield needing to be improved. The site furnishings are a mix of old and new styles and materials. On-street parking is available. The park has a significant amount of open land that could be used to provide other recreation amenities for the neighborhood and community.

Curb Appeal	Very Good
Access	Fair
Playground	Good
Site Furnishings	Good
Signage	Poor
Landscaping	Fair
Lawns	Fair
Ball Field	Fair
Maintenance	Good

- 2 Replace park sign
- 2 Redesign park sign landscape
- 2 Replace older benches
- 2 Replace bicycle rack
- 2 Convert ball field infield to turf
- 3 Replace playground
- 3 Move playground benches outside playground area
- 3 Add shade trees at the playground area and as shade for the benches
- 3 Provide soccer goals that can be used for neighborhood pickup games
- 4 Lengthen sidewalk to Sumner Street and work with Village to provide a crosswalk to the neighborhood
- 4 Consider adding an 18-hole disc golf course to the park
