8 Park Assessment

PARK EVALUATION CRITERIA

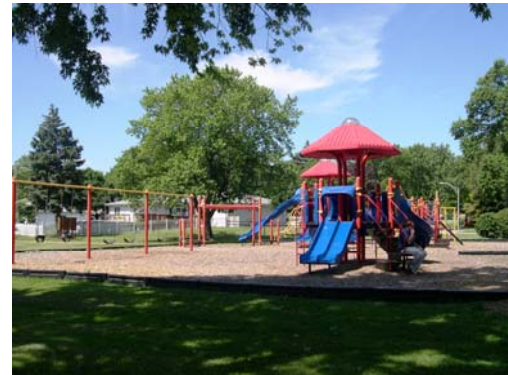
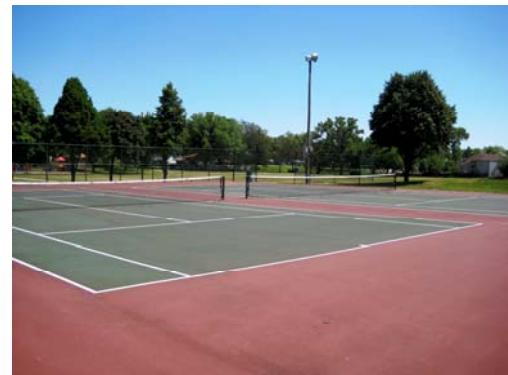
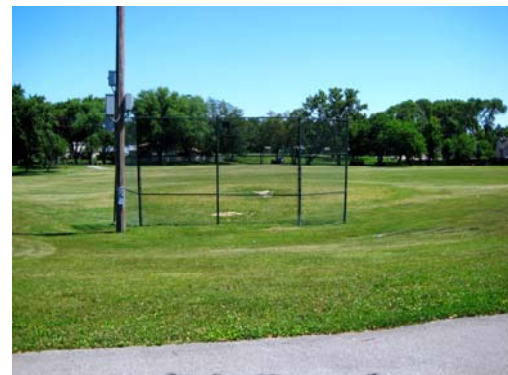
WESTVIEW PARK

Westview Park is a neighborhood park that offers a good variety of amenities to the area residents. The park is surrounded by a single-family residential neighborhood with Ardmore Elementary School also bordering the northeast corner. The park has very good curb appeal that is somewhat tempered by the park dedication/flagpole area that needs work. Public sidewalks provide access from most of the surrounding areas, with a perimeter trail system within the park that connects to all the amenities. There is an access way to Armitage, but no walkway has been developed. On-street parking at the park is limited by the curved road configuration. The playground offers good diversity and is in relatively good condition, but is nearing the end of its lifecycle. Site furnishings are relatively new but exhibiting peeling of the colorcoat. The tennis courts have a major crack and some fence repair needed, but are otherwise in relatively good condition for their age. The lawn areas exhibit significant weed growth.

Curb Appeal	Very Good
Access	Excellent
Playground	Good
Site Furnishings	Good
Signage	Very Good
Ball field	Good
Tennis	Good
Landscaping	Fair
Lawns	Poor
Maintenance	Fair

- 1 Convert ball field infield to turf
- 1 Sealcoat bituminous trails
- 1 Repair/replace sections of concrete trails that are cracked
- 1 Repair tennis court surface & fence
- 2 Redesign park dedication area and replace/remove flagpole
- 3 Add a bicycle rack
- 3 Replace playground
- 3 Add shade trees throughout the park, especially at the playground area and as shade for the benches and other amenities
- 4 Provide soccer goals that can be used for neighborhood pickup games
- 4 Provide a paved path from Armitage into the park

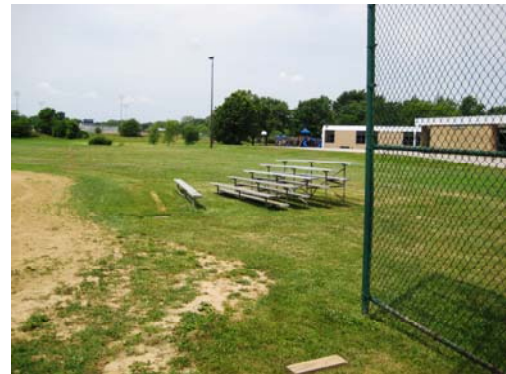
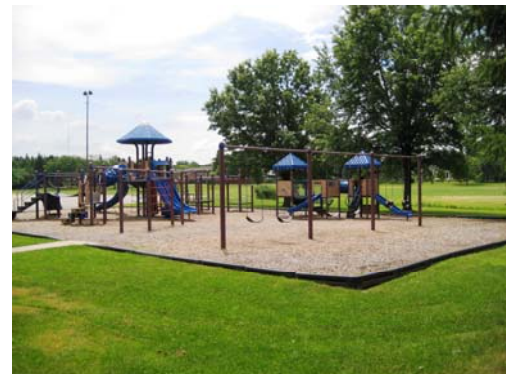
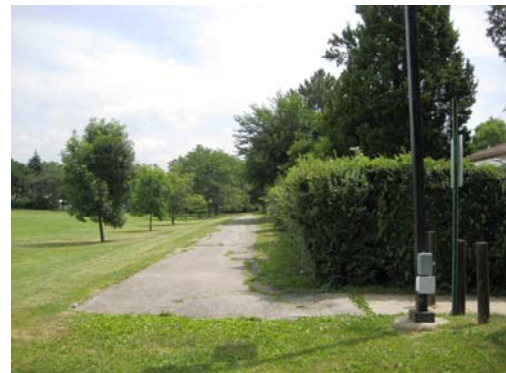
WESTWOOD PARK

Westwood Park is a neighborhood park that is nestled between the Wesley Elementary School and the athletic fields of Addison Trail High School. A single-family residential neighborhood is adjacent to the east and south, as well as to the north across Westwood Trail. Access to the park is good, with a trail from the street and sidewalks along the east and south boundaries that provide some access from those residential areas. The playground and fields are used by the elementary school children, and yet do not show the expected wear and tear that they could. The playground offers good diversity and subtle coloring. It is in good condition, though nearing the end of its lifecycle. The ball field has numerous problems, including safety issues that need to be resolved. There is a mix of trees at the entry, playground and perimeter of the park. Lawn areas exhibit significant weed growth in the area surrounding the playground and clover in other areas of the park. Basketball is available directly adjacent to the park in the school play area.

Curb Appeal	Very Good
Access	Very Good
Playground	Good
Site Furnishings	Good
Signage	Very Good
Ball field	Poor
Landscaping	Good
Lawns	Poor
Maintenance	Fair

- 2 Rebuild ball field backstop with side fencing for safety of players and spectators
- 2 Re-edge ball field infield and add infield mix
- 2 Replace bleachers and provide access path and pad
- 2 Replace playground
- 2 Add a bicycle rack
- 2 Provide landscaping at the park sign
- 2 Add paved aprons in front of benches
- 2 Provide soccer goals that can be used for school and neighborhood pickup games
- 4 Provide a paved path from the south access to the playground area to create a full loop trail
- 4 Add park sign at south entry into the park

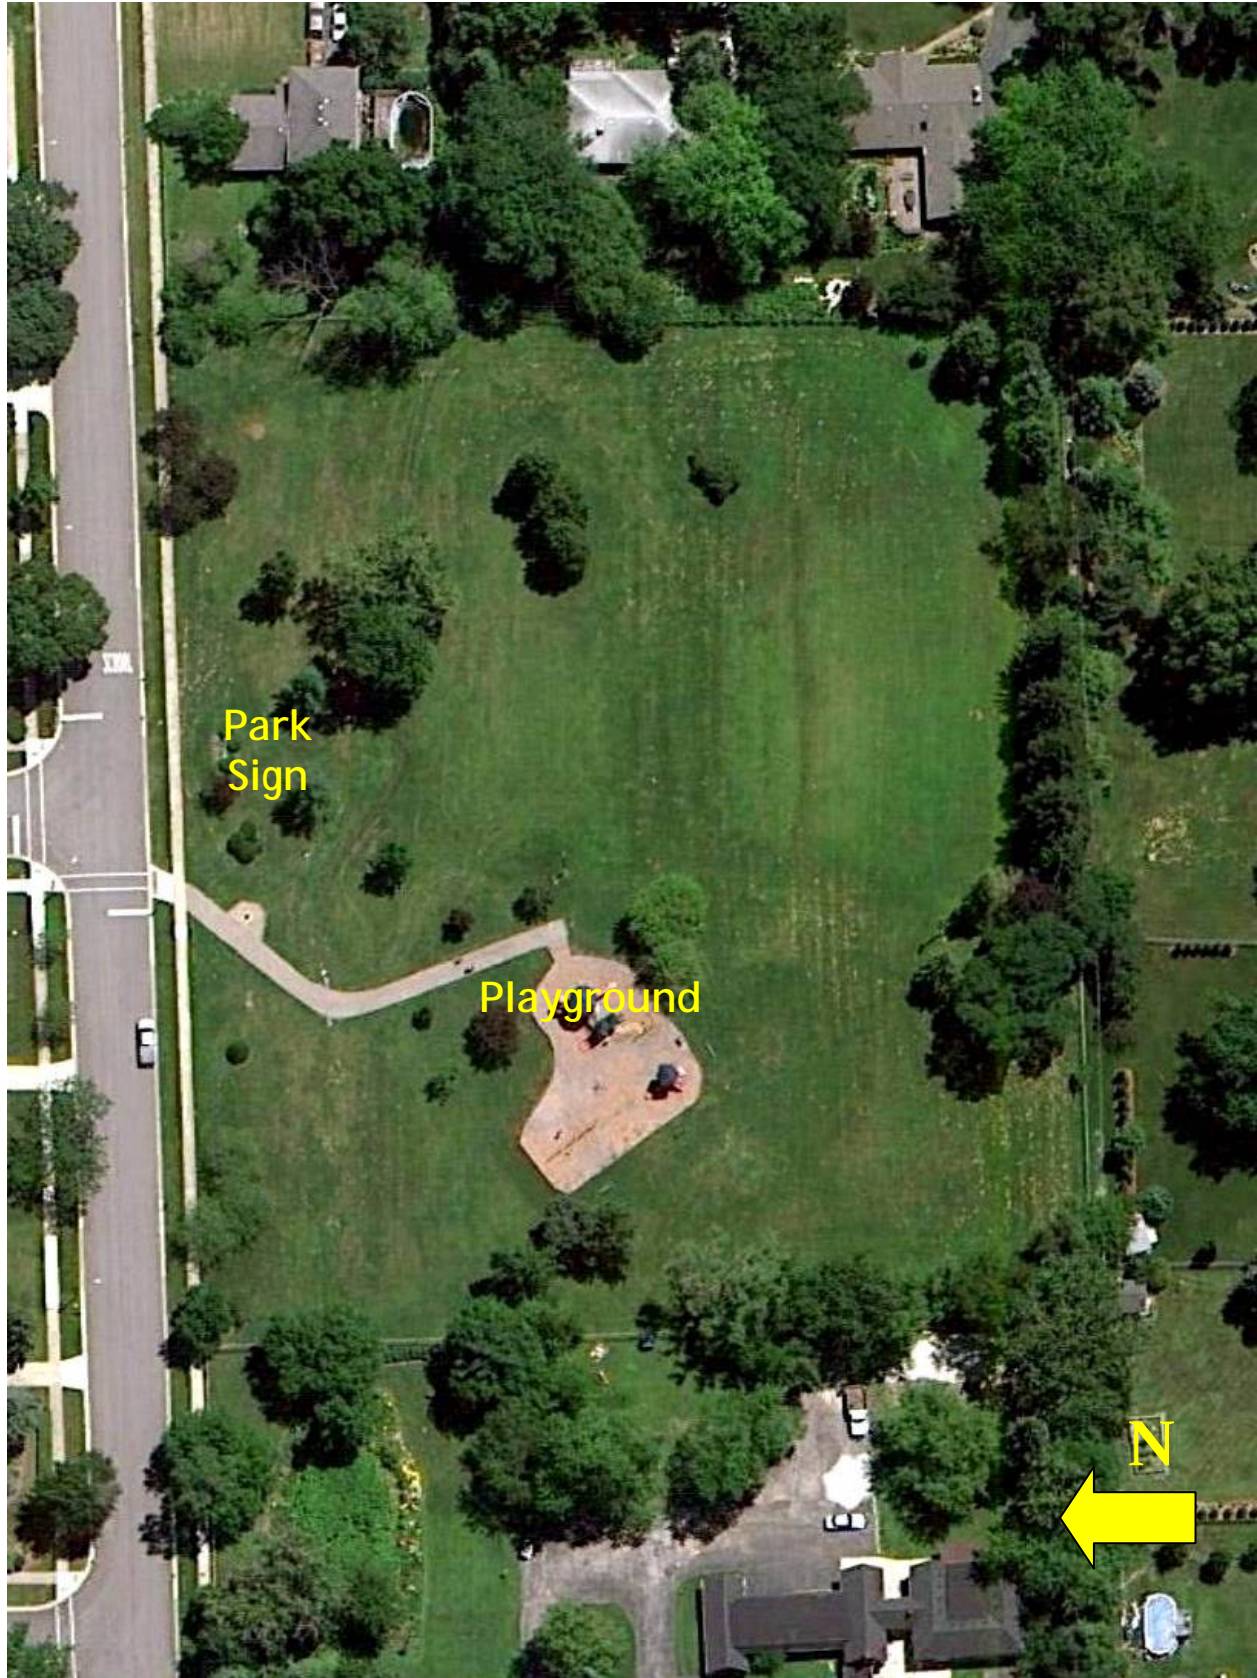
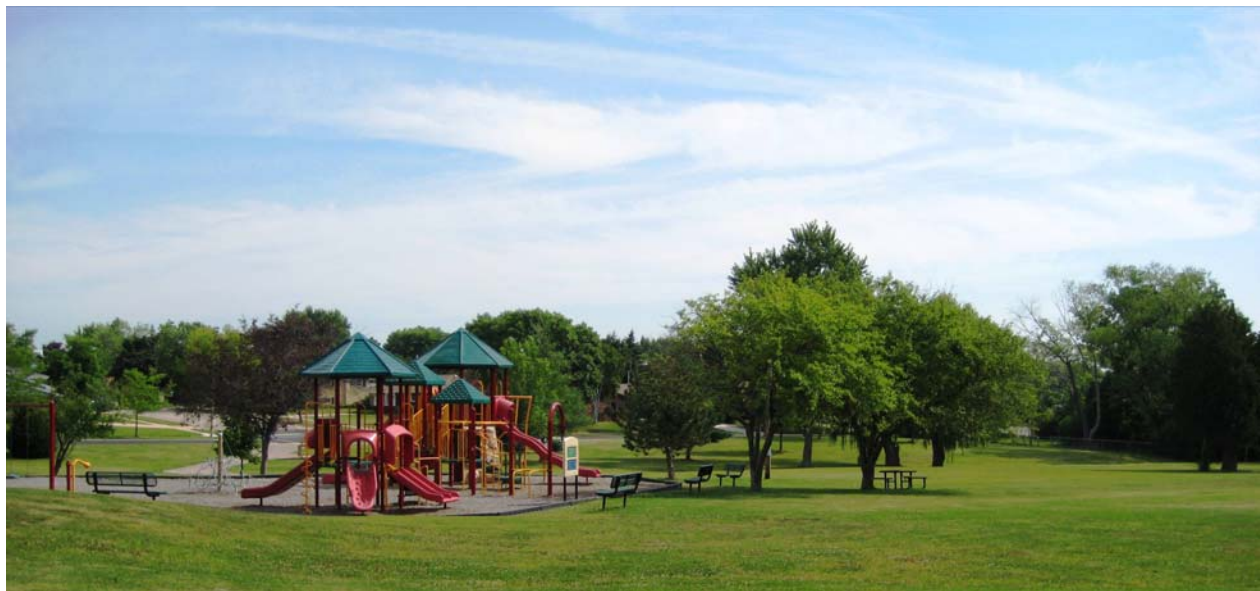
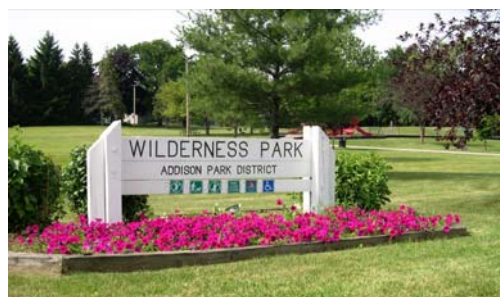
WILDERNESS PARK

Wilderness Park is a small neighborhood park in a nice residential neighborhood bordered on the west by a daycare center. The park provides a great open-space look from the street, and has easy access into the park from a public sidewalk. A bituminous trail provides access to the playground. The new playground offers a good variety of activities. New site furnishings were installed at the same time as the playground. The landscaping and lawns are some of the best in the APD system, though some tree maintenance is needed.

Curb Appeal	Excellent
Access	Very Good
Playground	Excellent
Site Furnishings	Very Good
Signage	Very Good
Landscaping	Very Good
Lawns	Very Good
Maintenance	Very Good

- 3 Add a bicycle rack
- 3 Add paved aprons in front of benches
- 3 Provide soccer goals that can be used for neighborhood pickup games
- 4 Add a half-court or three-point line basketball court
- 4 Consider adding three disc golf holes to provide a simple addition to the park amenities
